# Access Compliance Report

## Public Rights-of-Way

### (Curb Ramps)

| Intersection ID: 13660 | Main Street: BRENTWOOD_PL | Cross Street: REMOUNT_RD | Location: NW |

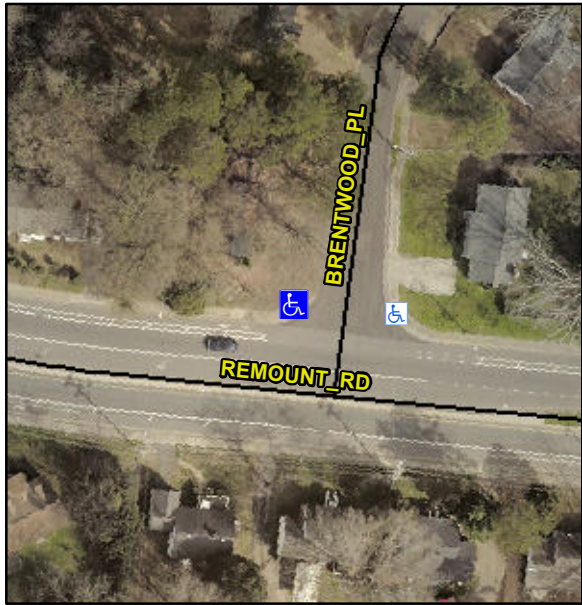
| ADA ID: F03F6294C262 | Ramp Type: PerpDiag | Initial Pass/Fail: Fail | Overall Compliance: No |

| Codes/Mitigation Info/Possible Solution | | | Field Measurements/Component Compliance | | | | | |
|---|---|---|---|---|---|---|---|---|
| | Remove & Replace Curb Ramp With Two New Directional Ramps or Equivalent. | | N/A | Ramp Length (in) | 58.0 | No | Ramp Slope (%) | 10.4 |
| | | | No | Ramp Width (in) | 45.0 | No | Ramp XSlope (%) | 5.2 |
| PROW/ADA: | | R304.5.1, R304.2.2, R304.5.3 | N/A | Shared Landing? | N/A | | | |
