Access Compliance Report

Public Rights-of-Way

(Curb Ramps)

Intersection ID: 7031	Main Street: BROOKSHIRE_BV	Cross Street: OAKDALE_RD	Location: SW
ADA ID: F040FACC932F	Ramp Type: Perp	Initial Pass/Fail: Pass	Overall Compliance: No
		Severity Score: 0

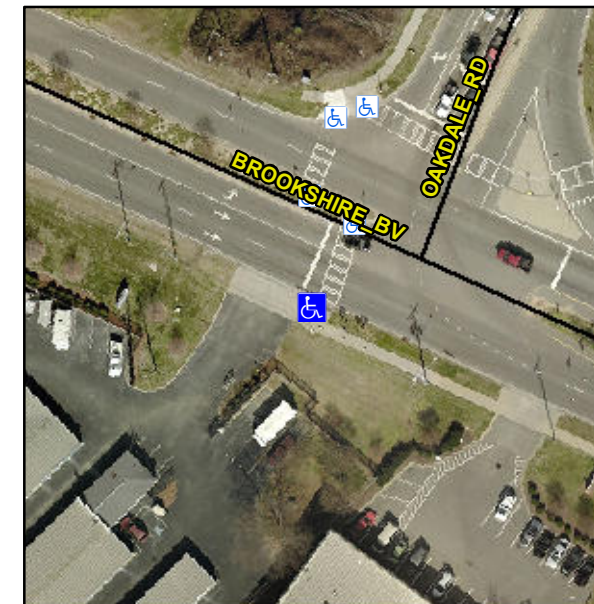
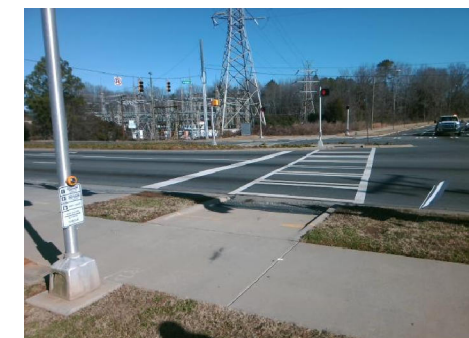
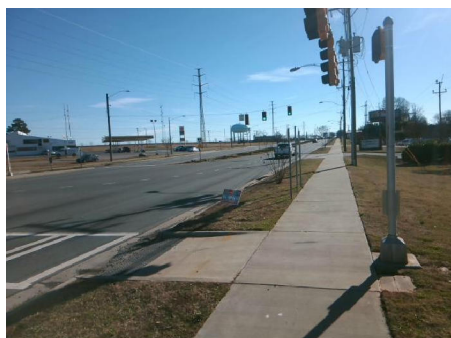
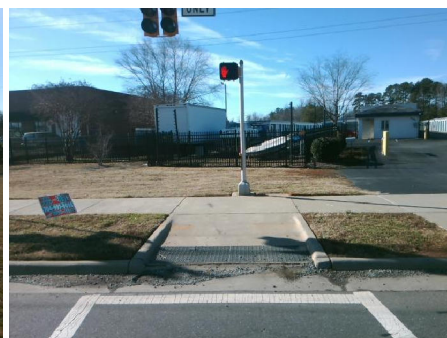
N/A

Compliance	Description	Data	Compliance	Description	Data
N/A	Ramp Length (in)	95.0	Yes	Ramp Slope (%)	5.6
Yes	Ramp Width (in)	93.0	Yes	Ramp XSlope (%)	2.0
Yes	Flare Type L	Curbed_NoWalkSurface	Yes	Flare Type RT	N/A
Yes	Flare Slope LT (%)	N/A	N/A	Flare Slope RT (%)	N/A
N/A	Flare Traversable LT?	No	N/A	Flare Traversable RT?	No
Yes	Landing Length (in)	72.0	Yes	DWS Provided?	Yes
Yes	Landing Width (in)	106.5	Yes	DWS Contrast?	Yes
Yes	Landing Slope (%)	1.4	Yes	DWS Length (in)	24.0
Yes	Landing X Slope (%)	1.6	Yes	DWS Full Width?	Yes
N/A	Landing Curb? (Y/N)	No	Yes	DWS Offset (in)	1.0
N/A	Shared Landing?	No			
Yes	Gutter Ponding?	No	Yes	Gutter Slope (%)	2.2
Yes	Gutter Lip Ht (in)	0.0	Yes	Gutter X Slope (%)	0.6
N/A	Painted X Walk1?	Yes	N/A	Painted X Walk2?	N/A
	X Walk 1 Direction	To NE		X Walk 2 Direction	N/A
N/A	X Walk 1 Width (in)	114.0	N/A	X Walk 2 Width (in)	N/A
	X Walk 1 Slope (%)	0.7		X Walk 2 Slope (%)	N/A
	X Walk 1 X Slope (%)	1.1		X Walk 2 X Slope (%)	N/A

Yes	Ramp inside XWalk1?	Yes	N/A	Ramp inside XWalk2?	N/A
	Road Slope (%)	N/A	N/A	Clear Space?	Yes
	Road X Slope (%)	N/A	N/A	Clear Space to XWalk (in)	N/A
Yes	Any Obstructions?	No	Yes	Storm Grate/Utility Hazard?	No
	Obstruction Type			Storm Grate/Utility Type	
		N/A			N/A
			Yes	Surface Condition? (G/P)	Good

Possible Solutions:

Remove & Replace Entire Ramp.

Total Cost: \$ 1850.00
