# Access Compliance Report

## Public Rights-of-Way

### (Curb Ramps)

Intersection ID: 13743	Main Street: DR_CARVER_RD	Cross Street: WEST_BV	Location: SW
ADA ID: F044B31C34B1	Ramp Type: ParaDiag	Initial Pass/Fail: Fail	Overall Compliance: No
Codes/Mitigation Info/Possible Solution		Field Measurements/Component Compliance	
Severity Score: 22.5

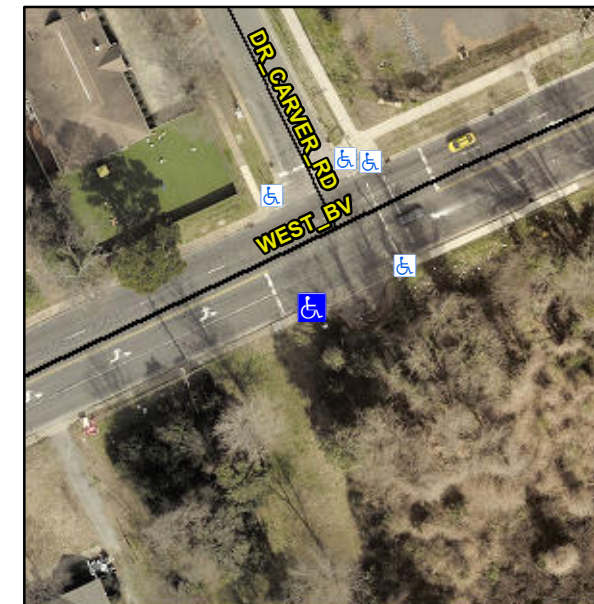
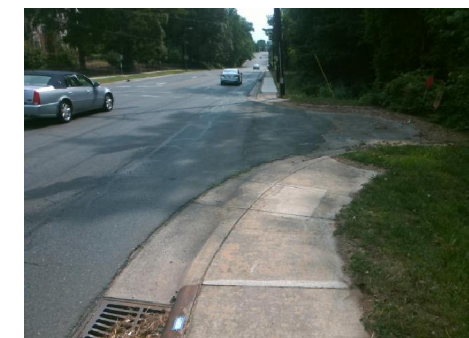
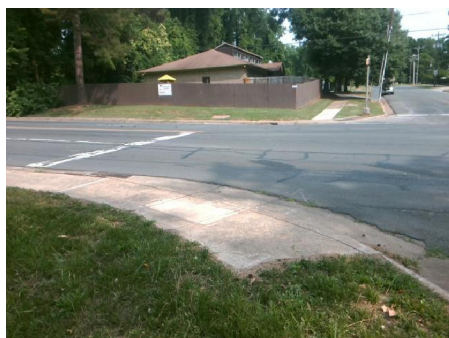
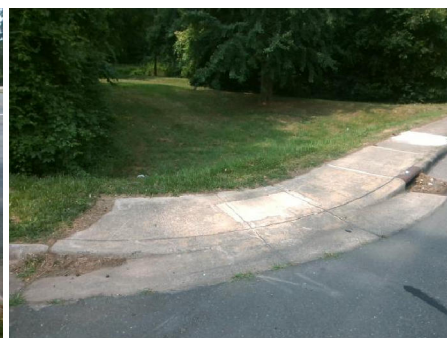
**DWS NAILS EXPOSED, LT RP < 5%**

Compliance	Description	Data	Compliance	Description	Data
N/A	Ramp Length LT (in)	59.0	N/A	Ramp Length RT (in)	57.0
No	Ramp Width LT (in)	47.0	No	Ramp Width RT (in)	47.0
Yes	Ramp Slope LT (%)	0.2	No	Ramp Slope RT (%)	11.3
No	Ramp XSlope LT (%)	2.8	Yes	Ramp XSlope RT (%)	1.4
N/A	Landing Length (in)	N/A	N/A	DWS Provided?	N/A
N/A	Landing Width (in)	N/A	N/A	DWS Contrast?	N/A
N/A	Landing Slope (%)	N/A	N/A	DWS Length (in)	N/A
N/A	Landing X Slope (%)	N/A	N/A	DWS Full Width?	N/A
N/A	Landing Curb? (Y/N)	N/A	N/A	DWS Offset (in)	N/A
N/A	Shared Landing?	N/A			
N/A	Gutter Ponding?	N/A	N/A	Gutter Slope (%)	N/A
N/A	Gutter Lip Ht (in)	N/A	N/A	Gutter X Slope (%)	N/A
N/A	Painted X Walk1?	No	N/A	Painted X Walk2?	No
	X Walk 1 Direction	To NE		X Walk 2 Direction	To NW
N/A	X Walk 1 Width (in)	N/A	N/A	X Walk 2 Width (in)	N/A
	X Walk 1 Slope (%)	3.1		X Walk 2 Slope (%)	2.1
	X Walk 1 X Slope (%)	3.1		X Walk 2 X Slope (%)	3.4
N/A	Ramp inside XWalk1?	N/A	N/A	Ramp inside XWalk2?	N/A

Road Slope (%)	3.6	N/A	Clear Space?	N/A
	Road X Slope (%)	2.7	N/A	Clear Space to XWalk (in)	N/A
N/A	Any Obstructions?	N/A	N/A	Storm Grate/Utility Hazard?	N/A
	Obstruction Type			Storm Grate/Utility Type	
		N/A			N/A
			Yes	Surface Condition? (G/P)	Good
			N/A	Curb Slope (%)	7.7

**Remove & Replace Curb Ramp With Two New Directional Ramps or Equivalent.**
