# Access Compliance Report

## Public Rights-of-Way

### (Curb Ramps)

Intersection ID: 13255	Main Street: CENTRAL_AV	Cross Street: IRIS_DR	Location: SE
ADA ID: F04A91082D2C	Ramp Type: BlendTrans1	Initial Pass/Fail: Fail	Overall Compliance: No
		Severity Score: 10

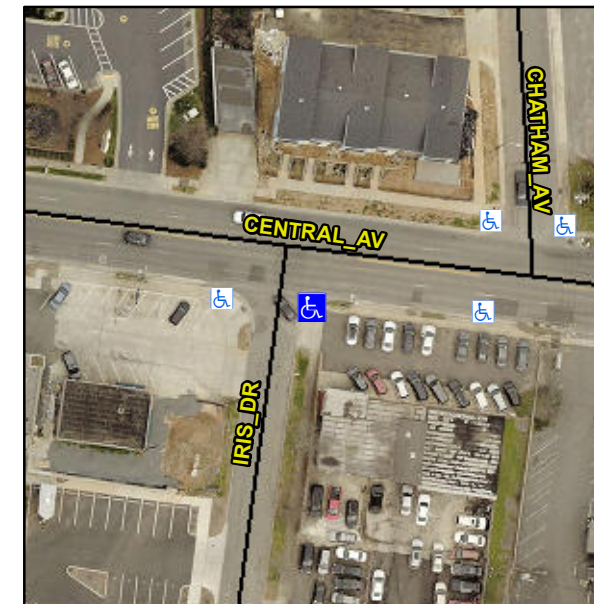
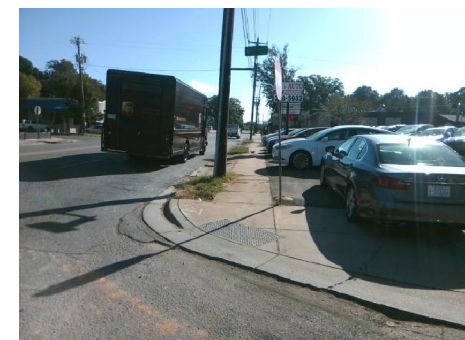
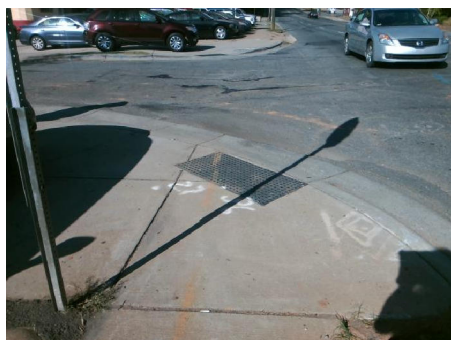
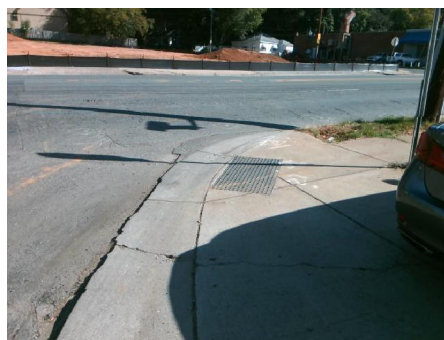
**Not Found, R304.5.1, R304.5.3**

Compliance	Description	Data	Compliance	Description	Data
N/A	Ramp Length (in)	32.0	Yes	BlendTrans Slope (%)	2.5
No	Ramp Width (in)	47.5	No	BlendTrans XSlope (%)	3.6
N/A	Flare Type LT	N/A	N/A	Flare Type RT	N/A
N/A	Flare Slope LT (%)	N/A	N/A	Flare Slope RT (%)	N/A
N/A	Flare Traversable LT?	N/A	N/A	Flare Traversable RT?	N/A
N/A	Landing Length (in)	N/A	N/A	DWS Provided?	N/A
N/A	Landing Width (in)	N/A	N/A	DWS Contrast?	N/A
N/A	Landing Slope (%)	N/A	N/A	DWS Length (in)	N/A
N/A	Landing X Slope (%)	N/A	N/A	DWS Full Width?	N/A
N/A	Landing Curb? (Y/N)	N/A	N/A	DWS Offset (in)	N/A
N/A	Shared Landing?	N/A			
N/A	Gutter Ponding?	N/A	N/A	Gutter Slope (%)	N/A
N/A	Gutter Lip Ht (in)	1.5	N/A	Gutter X Slope (%)	N/A
N/A	Painted X Walk1?	No	N/A	Painted X Walk2?	N/A
	X Walk 1 Direction	To W		X Walk 2 Direction	N/A
	X Walk 1 Width (in)	N/A		X Walk 2 Width (in)	N/A
	X Walk 1 Slope (%)	0.1		X Walk 2 Slope (%)	N/A
	X Walk 1 X Slope (%)	3.0		X Walk 2 X Slope (%)	N/A

N/A	Ramp inside XWalk1?	N/A	N/A	Ramp inside XWalk2?	N/A
	Road Slope (%)	3.0		Clear Space?	N/A
	Road X Slope (%)	0.1	N/A	Clear Space to XWalk (in)	N/A
N/A	Any Obstructions?	N/A	N/A	Storm Grate/Utility Hazard?	N/A
	Obstruction Type			Storm Grate/Utility Type	
		N/A			N/A
			Yes	Surface Condition? (G/P)	Good
			No	Curb Slope (%)	8.7

**Remove & Replace Curb Ramp With Two New Directional Ramps or Equivalent.**
