Access Compliance Report

Public Rights-of-Way

(Curb Ramps)

Intersection ID: N/A	Main Street: ELGIN_MOOR_RD	Cross Street: DOUGLAS_PALACE_CT	Location: NE
ADA ID: F04B5E645F7B	Ramp Type: Perp	Initial Pass/Fail: Fail	Overall Compliance: No
Severity Score: 12.5			
Codes/Mitigation Info/Possible Solution		Field Measurements/Component Compliance

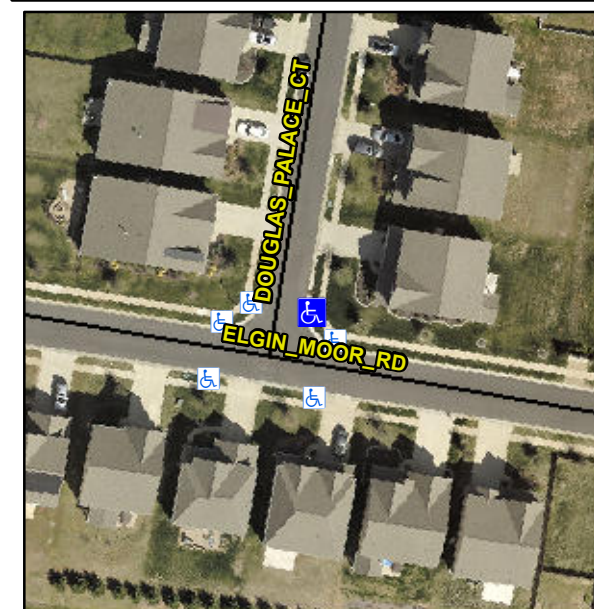
Not Found, R304.2.2

Compliance	Description	Data	Compliance	Description	Data
N/A	Ramp Length (in)	48.0	No	Ramp Slope (%)	8.9
Yes	Ramp Width (in)	48.0	Yes	Ramp XSlope (%)	0.1
N/A	Flare Type LT	N/A	N/A	Flare Type RT	N/A
N/A	Flare Slope LT (%)	N/A	N/A	Flare Slope RT (%)	N/A
N/A	Flare Traversable LT?	N/A	N/A	Flare Traversable RT?	N/A
N/A	Landing Length (in)	N/A	N/A	DWS Provided?	N/A
N/A	Landing Width (in)	N/A	N/A	DWS Contrast?	N/A
N/A	Landing Slope (%)	N/A	N/A	DWS Length (in)	N/A
N/A	Landing X Slope (%)	N/A	N/A	DWS Full Width?	N/A
N/A	Landing Curb? (Y/N)	N/A	N/A	DWS Offset (in)	N/A
N/A	Shared Landing?	N/A			
N/A	Gutter Ponding?	N/A	N/A	Gutter Slope (%)	N/A
N/A	Gutter Lip Ht (in)	N/A	N/A	Gutter X Slope (%)	N/A
N/A	Painted X Walk1?	No	N/A	Painted X Walk2?	N/A
	X Walk 1 Direction	To NW		X Walk 2 Direction	N/A
N/A	X Walk 1 Width (in)	N/A	N/A	X Walk 2 Width (in)	N/A
	X Walk 1 Slope (%)	1.0		X Walk 2 Slope (%)	N/A
	X Walk 1 X Slope (%)	0.3		X Walk 2 X Slope (%)	N/A

Remove & Replace Entire Ramp.
