Access Compliance Report

Public Rights-of-Way

(Curb Ramps)

| Intersection ID: 48791 | Main Street: HARDWOOD_WATCH_CT | Cross Street: WOODLAND_WATCH_CT | Location: S |

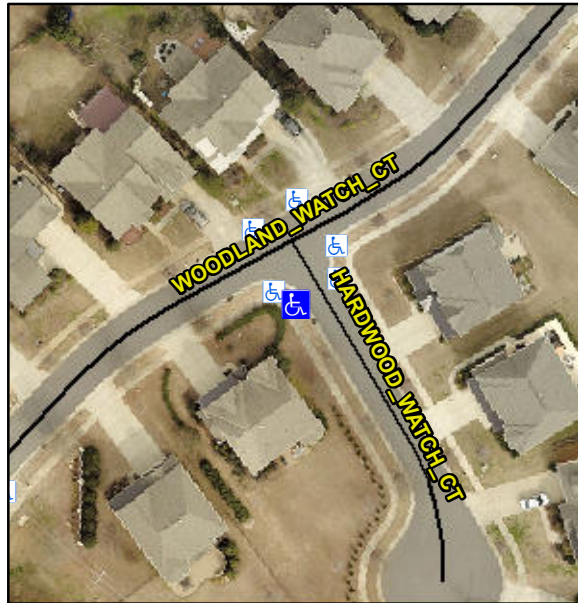
| ADA ID: F04EEA1E3363 | Ramp Type: Perp | Initial Pass/Fail: Fail | Overall Compliance: No |
| Severity Score: 12.5 | | | |

Not Found, R304.5.3

| Compliance | Description | Data | Compliance | Description | Data |
|---|---|---|---|---|---|
| Yes | Ramp Width (in) | 48.0 | No | Ramp XSlope (%) | 5.6 |

Possible Solutions:

Remove & Replace Entire Ramp.
