# Access Compliance Report

## Public Rights-of-Way

| Intersection ID: 27482 | Main Street: GRAHAMWOOD_PL | Cross Street: WILD_ELM_RD | Location: SE |
| ADA ID: F05242B50DB5 | Ramp Type: PerpDiag | Initial Pass/Fail: Fail | Overall Compliance: No |

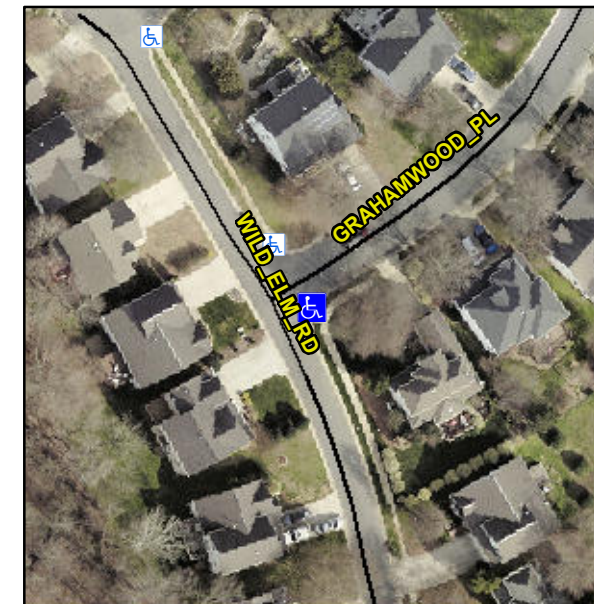
| | | Severity Score: 25 | |

**R304.5.3**

| Compliance | Description | Data | Compliance | Description | Data |
|---|---|---|---|---|---|
| N/A | Ramp Length (in) | 48.0 | Yes | Ramp Slope (%) | 7.1 |
| Yes | Ramp Width (in) | 48.0 | No | Ramp XSlope (%) | 10.1 |

**Remove & Replace Curb Ramp With Two New Directional Ramps or Equivalent.**

Total Cost: \$ 3200.00
