Access Compliance Report Public Rights-of-Way (Curb Ramps)

Intersection ID: 10033959 Main Street: PARK_RD Cross Street: N/A Location: SE **Overall Compliance: No ADA ID: F052DA27E13D** Ramp Type: Perp Initial Pass/Fail: Fail Severity Score: 13.75

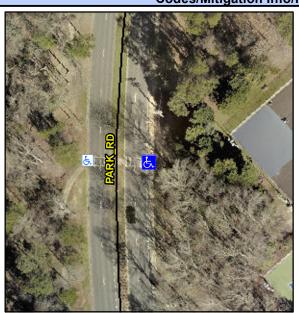
Field Measurements/Component Compliance								
Comp	liance Description	Data	Comp	liance	Description	Data		
N/A	Ramp Length (in)	59.0	No	Ramp	Slope (%)	9.8		
Yes	Ramp Width (in)	48.0	No	Ramp	XSlope (%)	3.6		
N/A	Flare Type LT	N/A	N/A	Flare	Type RT	N/A		
N/A	Flare Slope LT (%)	N/A	N/A	Flare	Slope RT (%)	N/A		
N/A	Flare Traversable LT?	N/A	N/A	Flare	Traversable RT?	N/A		
N/A	Landing Length (in)	N/A	N/A	DWS	Provided?	N/A		
N/A	Landing Width (in)	N/A	N/A	DWS	Contrast?	N/A		
N/A	Landing Slope (%)	N/A	N/A	DWS	Length (in)	N/A		
N/A	Landing X Slope (%)	N/A	N/A	DWS	Full Width?	N/A		
N/A	Landing Curb? (Y/N)	N/A	N/A	DWS	Offset (in)	N/A		
N/A	Shared Landing?	N/A						
N/A	Gutter Ponding?	N/A	N/A	Gutte	r Slope (%)	N/A		
N/A	Gutter Lip Ht (in)	N/A	N/A	Gutte	r X Slope (%)	N/A		
N/A	Painted X Walk1?	Yes	N/A	Paint	ed X Walk2?	N/A		
	X Walk 1 Direction	To NW		X Wa	lk 2 Direction	N/A		
N/A	X Walk 1 Width (in)	101.0	N/A	X Wa	lk 2 Width (in)	N/A

X Walk 1 Slope (%)	2.0		X Wa	lk 2 Slope (%)	N/A		
	X Walk 1 X Slope (%)	2.1		X Wa	lk 2 X Slope (%)	N/A		
N/A	Ramp inside XWalk1?	Yes	N/A	Ramp	inside XWalk2?	N/A		
	Road Slope (%)	N/A	N/A	Clear	Space?	N/A		
	Road X Slope (%)	N/A	N/A	Clear	Space to XWalk (in)	N/A		
N/A	Any Obstructions?	N/A	N/A	Storm	n Grate/Utility Hazard?	N/A		
	Obstruction Type			Storm	n Grate/Utility Type			
		N/A				N/A		
			Yes	Surfa	ce Condition? (G/P)	Good

Possible Solutions: Remove & Replace Entire Ramp. Surveyor Notes: N/A PROW/ADA: Not Found, R304.2.2, R304.5.3
