Intersection ID: 2666	Main Street: FAIRVISTA_DR	Cross Street: SUNBEAM_LN	Location:	S
ADA ID: F06215188C53	Ramp Type: PerpDiag	Initial Pass/Fail: Fail	Overall Compliance: No	Severity Score: 22.5

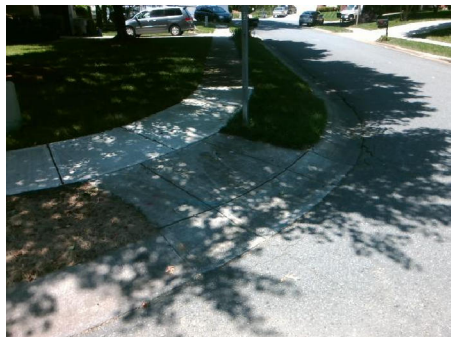
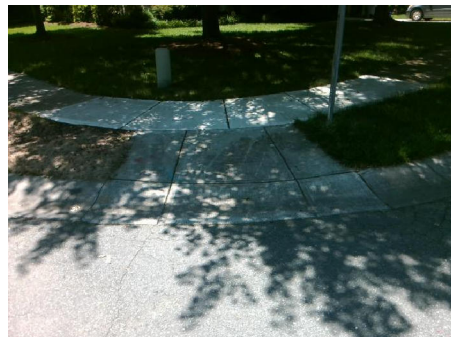
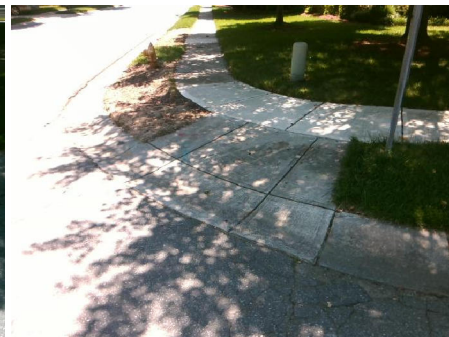
**Not Found, R304.5.1, R304.2.2,  
R304.5.3**

Compliance	Description	Data	Compliance	Description	Data
N/A	Ramp Length (in)	48.0	No	Ramp Slope (%)	10.7
No	Ramp Width (in)	38.0	No	Ramp XSlope (%)	4.7
N/A	Flare Type LT	N/A	N/A	Flare Type RT	N/A
N/A	Flare Slope LT (%)	N/A	N/A	Flare Slope RT (%)	N/A
N/A	Flare Traversable LT?	N/A	N/A	Flare Traversable RT?	N/A
N/A	Landing Length (in)	N/A	N/A	DWS Provided?	N/A
N/A	Landing Width (in)	N/A	N/A	DWS Contrast?	N/A
N/A	Landing Slope (%)	N/A	N/A	DWS Length (in)	N/A
N/A	Landing X Slope (%)	N/A	N/A	DWS Full Width?	N/A
N/A	Landing Curb? (Y/N)	N/A	N/A	DWS Offset (in)	N/A
N/A	Shared Landing?	N/A			
N/A	Gutter Ponding?	N/A	N/A	Gutter Slope (%)	N/A
N/A	Gutter Lip Ht (in)	N/A	N/A	Gutter X Slope (%)	N/A
N/A	Painted X Walk1?	No	N/A	Painted X Walk2?	No
	X Walk 1 Direction	To NE		X Walk 2 Direction	To NW
N/A	X Walk 1 Width (in)	N/A	N/A	X Walk 2 Width (in)	N/A
	X Walk 1 Slope (%)	3.0		X Walk 2 Slope (%)	1.6
	X Walk 1 X Slope (%)	2.7		X Walk 2 X Slope (%)	2.7

N/A	Ramp inside XWalk1?	N/A	N/A	Ramp inside XWalk2?	N/A
	Road Slope (%)	2.8	N/A	Clear Space?	N/A
	Road X Slope (%)	2.2	N/A	Clear Space to XWalk (in)	N/A
N/A	Any Obstructions?	N/A	N/A	Storm Grate/Utility Hazard?	N/A
	Obstruction Type			Storm Grate/Utility Type	
		N/A			N/A
			Yes	Surface Condition? (G/P)	Good

**Remove & Replace Curb Ramp With Two New Directional Ramps or Equivalent.**
