Access Compliance Report Public Rights-of-Way (Curb Ramps)

Intersection ID: 15728 Main Street: MARNEY_AV Cross Street: SAM_DRENAN_RD Location: SE

ADA ID: F0644FE8AE11 Ramp Type: PerpDiag Initial Pass/Fail: Fail Overall Compliance: No Severity Score: 13.75

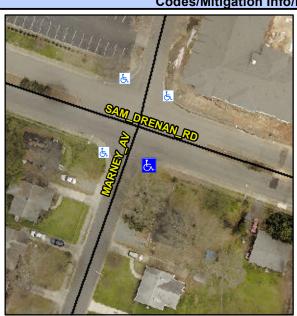
Not Found, R304.2.2, R304.5.3

Compliance Description		Data	Comp	liance Description	on Data
N/A	Ramp Length (in)	49.0	No	Ramp Slope (%)	11.0
Yes	Ramp Width (in)	48.0	No	Ramp XSlope (%)	4.7
N/A	Flare Type LT	N/A	N/A	Flare Type RT	N/A
N/A	Flare Slope LT (%)	N/A	N/A	Flare Slope RT (%)	N/A
N/A	Flare Traversable LT?	N/A	N/A	Flare Traversable RT?	N/A
N/A	Landing Length (in)	N/A	N/A	DWS Provided?	N/A
N/A	Landing Width (in)	N/A	N/A	DWS Contrast?	N/A
N/A	Landing Slope (%)	N/A	N/A	DWS Length (in)	N/A
N/A	Landing X Slope (%)	N/A	N/A	DWS Full Width?	N/A
N/A	Landing Curb? (Y/N)	N/A	N/A	DWS Offset (in)	N/A
N/A	Shared Landing?	N/A			
N/A	Gutter Ponding?	N/A	N/A	Gutter Slope (%)	N/A
N/A	Gutter Lip Ht (in)	N/A	N/A	Gutter X Slope (%)	N/A
N/A	Painted X Walk1?	No	N/A	Painted X Walk2?	No
	X Walk 1 Direction	To NE		X Walk 2 Direction	To NW
N/A	X Walk 1 Width (in)	N/A	N/A	X Walk 2 Width (in)	N/A
	X Walk 1 Slope (%)	9.2		X Walk 2 Slope (%)	6.0
	X Walk 1 X Slope (%)	8.2		X Walk 2 X Slope (%)	4.3

N/A	Ramp inside XWalk1?	N/A	N/A	Ramp inside XWalk2?	N/A
	Road Slope (%)	4.6	N/A	Clear Space?	N/A
	Road X Slope (%)	8.6	N/A	Clear Space to XWalk	(in) N/A
N/A	Any Obstructions?	N/A	N/A	Storm Grate/Utility Ha	zard? N/A
	Obstruction Type			Storm Grate/Utility Typ	oe

Remove & Replace Curb Ramp With
Two New Directional Ramps or
Equivalent.
