Access Compliance Report

Public Rights-of-Way

(Curb Ramps)

Intersection ID: 42737	Main Street: CALDWELL_FOREST_DR	Cross Street: CARLEEN_WAY_DR	Location: S
ADA ID: F06736CFB139	Ramp Type: PerpDiag	Initial Pass/Fail: Fail	Overall Compliance: No
			Severity Score: 33.75

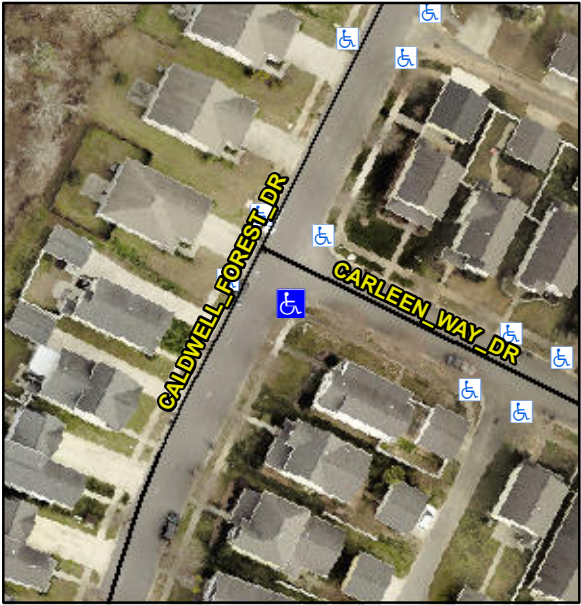
Possible Solutions:		Compliance	Description	Data
	Remove & Replace Curb Ramp With Two New Directional Ramps or Equivalent.		No	Ramp Length (in)	49.0
			No	Ramp Width (in)	47.0
			N/A	Flare Type LT	N/A
			N/A	Flare Slope LT (%)	N/A
			N/A	Flare Traversable LT?	N/A
			N/A	Landing Length (in)	N/A
			N/A	Landing Width (in)	N/A
			N/A	Landing Slope (%)	N/A
			N/A	Landing X Slope (%)	N/A
			N/A	Landing Curb? (Y/N)	N/A
			N/A	Shared Landing?	N/A
			N/A	Gutter Ponding?	N/A
			N/A	Gutter Lip Ht (in)	N/A
			N/A	Painted X Walk1?	No
				X Walk 1 Direction	To N
			N/A	X Walk 1 Width (in)	N/A
				X Walk 1 Slope (%)	3.3
				X Walk 1 X Slope (%)	2.3
			N/A	Ramp inside XWalk1?	N/A
<p>Surveyor Notes:</p> <p>N/A</p> <p>PROW/ADA:</p> <p>R304.5.1, R304.2.2</p>			N/A	Flare Type RT	N/A
			N/A	Flare Slope RT (%)	N/A
			N/A	Flare Traversable RT?	N/A

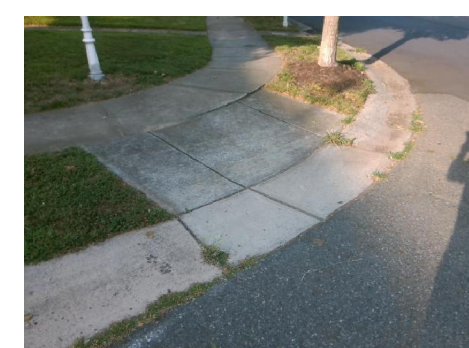
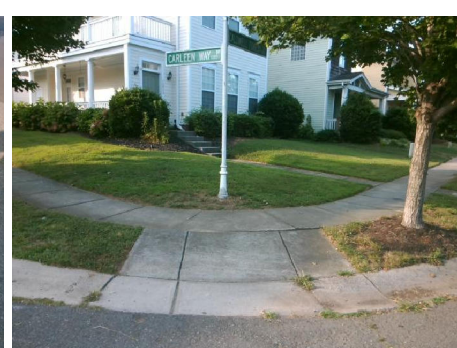
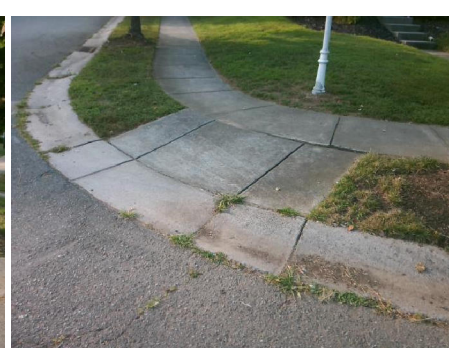
N/A	DWS Provided?	N/A
			N/A	DWS Contrast?	N/A
			N/A	DWS Length (in)	N/A
			N/A	DWS Full Width?	N/A
			N/A	DWS Offset (in)	N/A
			N/A	Gutter Slope (%)	N/A
			N/A	Gutter X Slope (%)	N/A
			N/A	Painted X Walk2?	No
				X Walk 2 Direction	To W
			N/A	X Walk 2 Width (in)	N/A
				X Walk 2 Slope (%)	0.4
				X Walk 2 X Slope (%)	1.7
			N/A	Ramp inside XWalk2?	N/A
			N/A	Clear Space?	N/A
			N/A	Clear Space to XWalk (in)	N/A
			N/A	Storm Grate/Utility Hazard?	N/A
				Storm Grate/Utility Type	
<p>Total Cost:</p> <p>\$ 3200.00</p>			N/A		N/A
			Yes	Surface Condition? (G/P)	Good
