Access Compliance Report

Public Rights-of-Way

(Curb Ramps)

Intersection ID: 42362	Main Street: OSPREY_KNOLL_DR	Cross Street: HERON_GLEN_DR	Location: E
ADA ID: F07B6B44DE54	Ramp Type: BlendTrans1	Initial Pass/Fail: Fail	Overall Compliance: No
Severity Score: 8.75			
Codes/Mitigation Info/Possible Solution		Field Measurements/Component Compliance

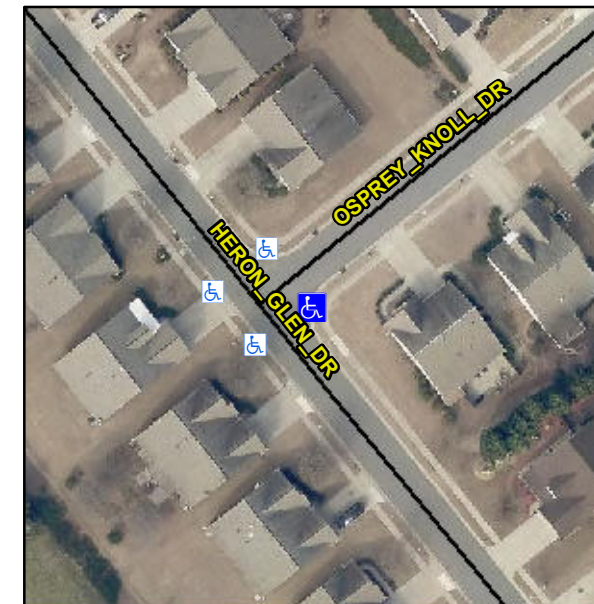
Compliance	Description	Data	Compliance	Description	Data
N/A	Ramp Length (in)	46.0	Yes	BlendTrans Slope (%)	2.6
No	Ramp Width (in)	38.0	Yes	BlendTrans XSlope (%)	2.0
N/A	Flare Type LT	N/A	N/A	Flare Type RT	N/A
N/A	Flare Slope LT (%)	N/A	N/A	Flare Slope RT (%)	N/A
N/A	Flare Traversable LT?	N/A	N/A	Flare Traversable RT?	N/A
N/A	Landing Length (in)	N/A	N/A	DWS Provided?	N/A
N/A	Landing Width (in)	N/A	N/A	DWS Contrast?	N/A
N/A	Landing Slope (%)	N/A	N/A	DWS Length (in)	N/A
N/A	Landing X Slope (%)	N/A	N/A	DWS Full Width?	N/A
N/A	Landing Curb? (Y/N)	N/A	N/A	DWS Offset (in)	N/A
N/A	Shared Landing?	N/A			
N/A	Gutter Ponding?	N/A	N/A	Gutter Slope (%)	N/A
N/A	Gutter Lip Ht (in)	N/A	N/A	Gutter X Slope (%)	N/A
N/A	Painted X Walk1?	No	N/A	Painted X Walk2?	No
	X Walk 1 Direction	To NW		X Walk 2 Direction	To SW
	X Walk 1 Width (in)	N/A		X Walk 2 Width (in)	N/A
	X Walk 1 Slope (%)	3.6		X Walk 2 Slope (%)	0.7
	X Walk 1 X Slope (%)	1.9		X Walk 2 X Slope (%)	2.2

N/A	Ramp inside XWalk1?	N/A	N/A	Ramp inside XWalk2?	N/A
	Road Slope (%)	1.8		Clear Space?	N/A
	Road X Slope (%)	2.1	N/A	Clear Space to XWalk (in)	N/A
N/A	Any Obstructions?	N/A	N/A	Storm Grate/Utility Hazard?	N/A
	Obstruction Type			Storm Grate/Utility Type	
		N/A			N/A
			Yes	Surface Condition? (G/P)	Good
			No	Curb Slope (%)	15.4

Remove & Replace Curb Ramp With Two New Directional Ramps or Equivalent.
