Access Compliance Report

Public Rights-of-Way

(Curb Ramps)

Intersection ID: 45761	Main Street: SOLACE_CT	Cross Street: GRANDEUR_RD	Location: NE
ADA ID: F08484A72E61	Ramp Type: PerpDiag	Initial Pass/Fail: Fail	Overall Compliance: No
Severity Score: 21.25			
Codes/Mitigation Info/Possible Solution		Field Measurements/Component Compliance

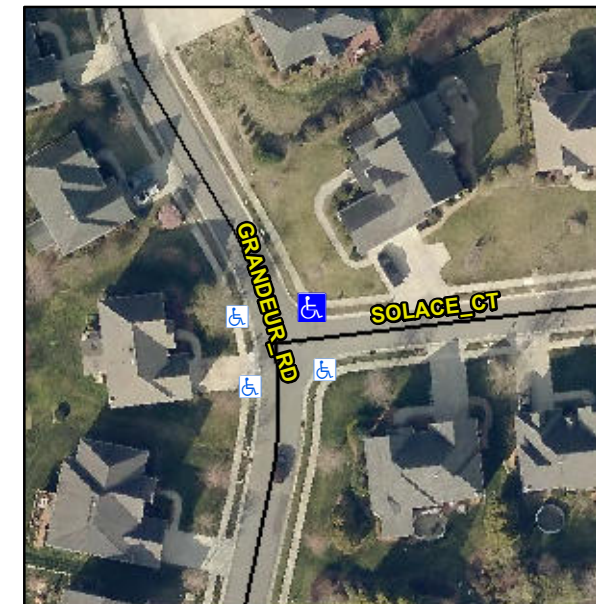
Not Found, R304.5.1, R304.5.3

Compliance	Description	Data	Compliance	Description	Data
N/A	Ramp Length (in)	46.0	Yes	Ramp Slope (%)	6.8
No	Ramp Width (in)	40.0	No	Ramp XSlope (%)	5.6
N/A	Flare Type LT	N/A	N/A	Flare Type RT	N/A
N/A	Flare Slope LT (%)	N/A	N/A	Flare Slope RT (%)	N/A
N/A	Flare Traversable LT?	N/A	N/A	Flare Traversable RT?	N/A
N/A	Landing Length (in)	N/A	N/A	DWS Provided?	N/A
N/A	Landing Width (in)	N/A	N/A	DWS Contrast?	N/A
N/A	Landing Slope (%)	N/A	N/A	DWS Length (in)	N/A
N/A	Landing X Slope (%)	N/A	N/A	DWS Full Width?	N/A
N/A	Landing Curb? (Y/N)	N/A	N/A	DWS Offset (in)	N/A
N/A	Shared Landing?	N/A			
N/A	Gutter Ponding?	N/A	N/A	Gutter Slope (%)	N/A
N/A	Gutter Lip Ht (in)	N/A	N/A	Gutter X Slope (%)	N/A
N/A	Painted X Walk1?	No	N/A	Painted X Walk2?	No
	X Walk 1 Direction	To W		X Walk 2 Direction	To S
N/A	X Walk 1 Width (in)	N/A	N/A	X Walk 2 Width (in)	N/A
	X Walk 1 Slope (%)	1.7		X Walk 2 Slope (%)	9.2
	X Walk 1 X Slope (%)	7.9		X Walk 2 X Slope (%)	1.6

N/A	Ramp inside XWalk1?	N/A	N/A	Ramp inside XWalk2?	N/A
	Road Slope (%)	5.1	N/A	Clear Space?	N/A
	Road X Slope (%)	8.4	N/A	Clear Space to XWalk (in)	N/A
N/A	Any Obstructions?	N/A	N/A	Storm Grate/Utility Hazard?	N/A
	Obstruction Type			Storm Grate/Utility Type	
		N/A			N/A
		Yes		Surface Condition? (G/P)	Good

Remove & Replace Curb Ramp With Two New Directional Ramps or Equivalent.
