# Access Compliance Report

## Public Rights-of-Way (Curb Ramps)

| Intersection ID: 28367 | Main Street: SOUTHAMPTON COMMONS DR | Cross Street: TRAVIS GULCH DR | Location: SW |
| ADA ID: F093FB15A975 | Ramp Type: Perp | Initial Pass/Fail: Fail | Overall Compliance: No |

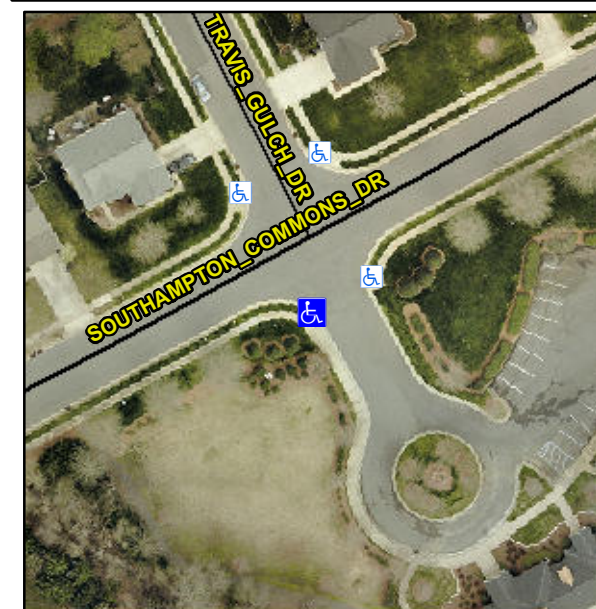
**Not Found, R304.5.1, R304.2.2, R304.5.3**

| Compliance | Description | Data | Compliance | Description | Data |
|---|---|---|---|---|---|
| N/A | Ramp Length (in) | 48.0 | No | Ramp Slope (%) | 8.5 |
| No | Ramp Width (in) | 29.0 | No | Ramp XSlope (%) | 4.5 |

**Remove & Replace Entire Ramp.**
