Access Compliance Report

Public Rights-of-Way

(Curb Ramps)

| Intersection ID: 31185 | Main Street: CARVER_POND_RD | Cross Street: CLOVERSIDE_LN | Location: NW |

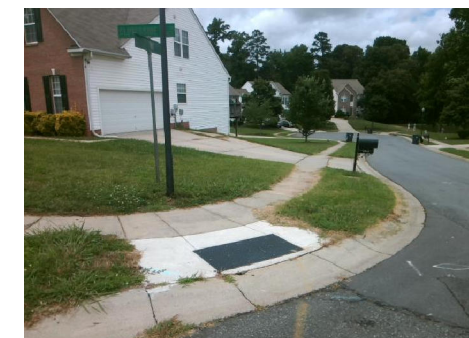
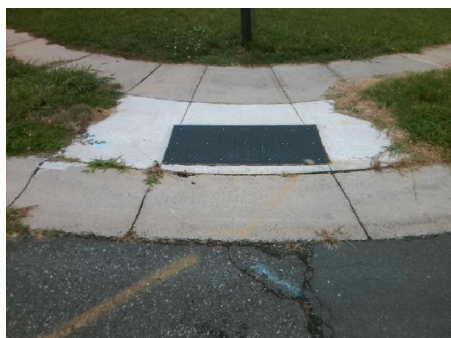
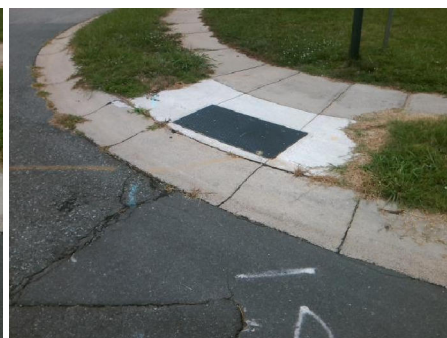
| ADA ID: F094C2ED38B0 | Ramp Type: PerpDiag | Initial Pass/Fail: Fail | Overall Compliance: No |
| Severity Score: 21.25 | | | |

Not Found, R304.5.1, R304.5.3

| Compliance | Description | Data | Compliance | Description | Data |
|---|---|---|---|---|---|
| N/A | Ramp Length (in) | 48.0 | Yes | Ramp Slope (%) | 5.0 |
| No | Ramp Width (in) | 38.0 | No | Ramp XSlope (%) | 5.8 |

Remove & Replace Curb Ramp With Two New Directional Ramps or Equivalent.

Total Cost: \$ 3200.00
