Access Compliance Report

Public Rights-of-Way

| Intersection ID: 11617 | Main Street: N_SMITH_ST | Cross Street: W_6TH_ST | Location: N |
| ADA ID: F0960B7EFF4E | Ramp Type: PerpDiag | Initial Pass/Fail: Fail | Overall Compliance: No |

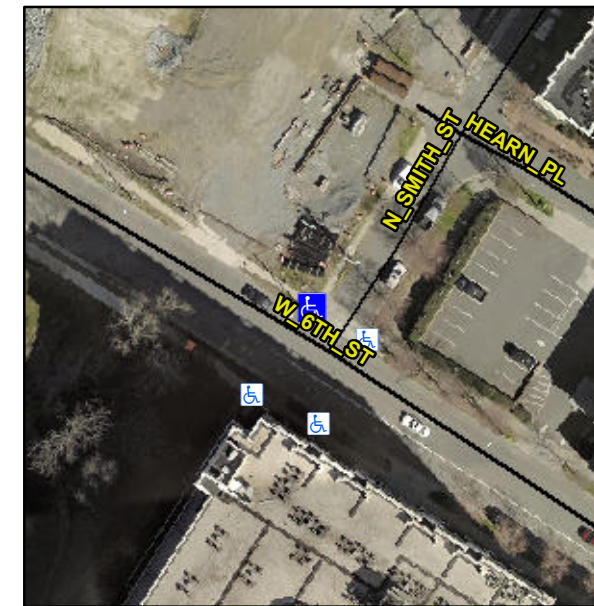
| | | | Severity Score: 48.75 |

Not Found, R304.5.1, R304.2.2, R304.5.3

| Compliance | Description | Data | Compliance | Description | Data |
|---|---|---|---|---|---|
| N/A | Ramp Length (in) | 64.0 | No | Ramp Slope (%) | 10.8 |
| No | Ramp Width (in) | 30.0 | No | Ramp XSlope (%) | 4.0 |

Remove & Replace Curb Ramp With Two New Directional Ramps or Equivalent.
