# Access Compliance Report

## Public Rights-of-Way

### (Curb Ramps)

Intersection ID: 43934	Main Street: ALBEMARLE_RD	Cross Street: CIRCUMFERENTIAL_RD	Location: SE
ADA ID: F0962B9BCC0B	Ramp Type: Para	Initial Pass/Fail: Fail	Overall Compliance: No
Severity Score: 13.75			
Codes/Mitigation Info/Possible Solution		Field Measurements/Component Compliance

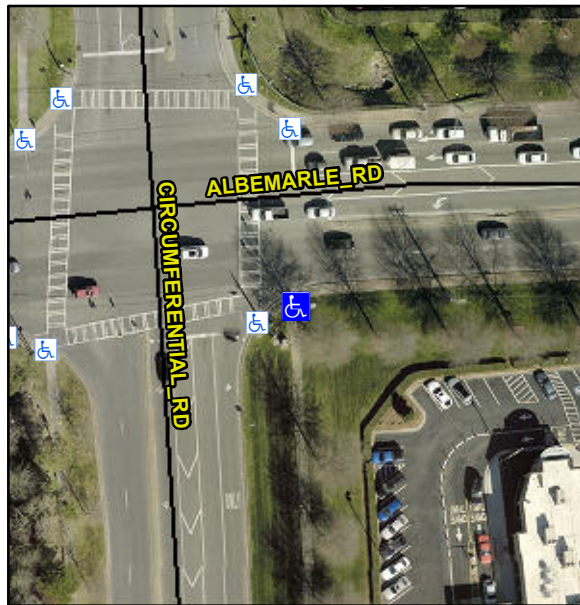
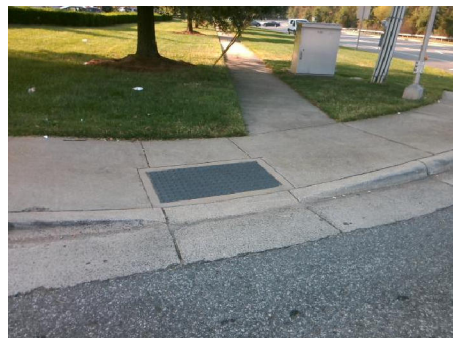
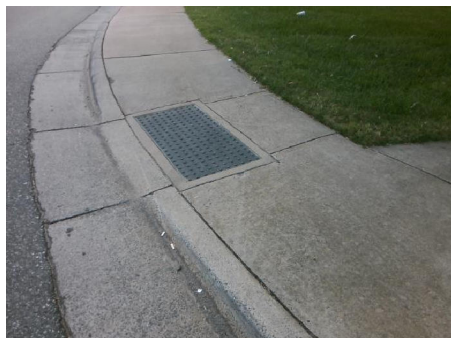
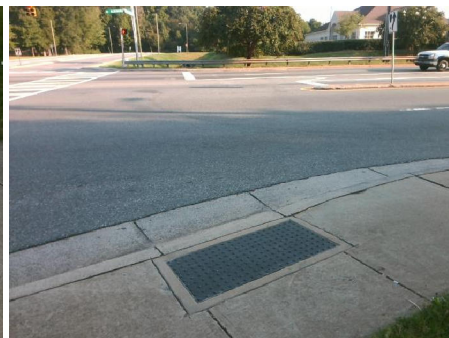
**RT RP < 5%**

**R304.3.2, R304.5.3**

Compliance	Description	Data	Compliance	Description	Data
N/A	Ramp Length LT (in)	60.0	N/A	Ramp Length RT (in)	79.5
Yes	Ramp Width LT (in)	60.0	Yes	Ramp Width RT (in)	60.0
No	Ramp Slope LT (%)	11.0	Yes	Ramp Slope RT (%)	1.8
No	Ramp XSlope LT (%)	3.9	No	Ramp XSlope RT (%)	2.4
N/A	Landing Length (in)	N/A	N/A	DWS Provided?	N/A
N/A	Landing Width (in)	N/A	N/A	DWS Contrast?	N/A
N/A	Landing Slope (%)	N/A	N/A	DWS Length (in)	N/A
N/A	Landing X Slope (%)	N/A	N/A	DWS Full Width?	N/A
N/A	Landing Curb? (Y/N)	N/A	N/A	DWS Offset (in)	N/A
N/A	Shared Landing?	N/A			
N/A	Gutter Ponding?	N/A	N/A	Gutter Slope (%)	N/A
N/A	Gutter Lip Ht (in)	N/A	N/A	Gutter X Slope (%)	N/A
N/A	Painted X Walk1?	No	N/A	Painted X Walk2?	N/A
	X Walk 1 Direction	To N		X Walk 2 Direction	N/A
N/A	X Walk 1 Width (in)	N/A	N/A	X Walk 2 Width (in)	N/A
	X Walk 1 Slope (%)	4.3		X Walk 2 Slope (%)	N/A
	X Walk 1 X Slope (%)	1.4		X Walk 2 X Slope (%)	N/A
N/A	Ramp inside XWalk1?	N/A	N/A	Ramp inside XWalk2?	N/A

Road Slope (%)	N/A	N/A	Clear Space?	N/A
	Road X Slope (%)	N/A	N/A	Clear Space to XWalk (in)	N/A
N/A	Any Obstructions?	N/A	N/A	Storm Grate/Utility Hazard?	N/A
	Obstruction Type			Storm Grate/Utility Type	
		N/A			N/A
			Yes	Surface Condition? (G/P)	Good
			N/A	Curb Slope (%)	11.8

**Remove & Replace Entire Ramp.**
