## Access Compliance Report Public Rights-of-Way (Curb Ramps)

Intersection ID: 10032537Main Street: N\_COLLEGE\_STCross Street: N/ALocation:NADA ID: F09C792ACB8FRamp Type: PerpInitial Pass/Fail: FailOverall Compliance: NoSeverity Score: 8.75

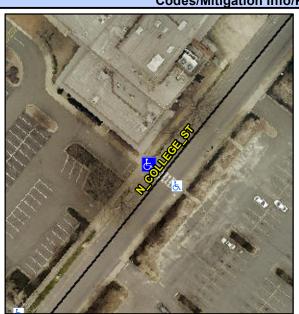
Ramp Slope (%)

Ramp XSlope (%)

57.5

47.5

Possible Solutions:					
Remove & Replace Entire Ramp.					
Surveyor Notes:					
N/A					
DDOIN/ADA					
PROW/ADA:					
R304.5.1

Total Cost: \$ 1850.00
