## Access Compliance Report Public Rights-of-Way (Curb Ramps)

Intersection ID: 11839 Main Street: FLEETWOOD\_DR Cross Street: EVERGREEN\_DR Location: SW

ADA ID: F0A0B4EBAC27 Ramp Type: Perp Initial Pass/Fail: Fail Overall Compliance: No Severity Score: 13.75

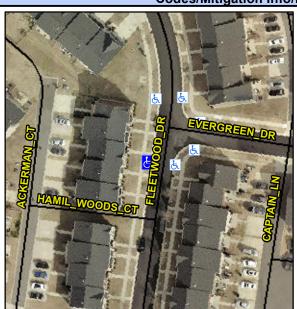
Comp	liance Description	Data	Comp	oliance [	Description	Data
N/A	Ramp Length (in)	70.5	No	Ramp S	Slope (%)	8.6
Yes	Ramp Width (in)	48.0	Yes	Ramp )	(Slope (%)	4.1
N/A	Flare Type LT	N/A	N/A	Flare T	ype RT	N/A
N/A	Flare Slope LT (%)	N/A	N/A	Flare S	lope RT (%)	N/A
N/A	Flare Traversable LT?	N/A	N/A	Flare T	raversable RT?	N/A
N/A	Landing Length (in)	N/A	N/A	DWS P	rovided?	N/A
N/A	Landing Width (in)	N/A	N/A	DWS C	Contrast?	N/A
N/A	Landing Slope (%)	N/A	N/A	DWS L	ength (in)	N/A
N/A	Landing X Slope (%)	N/A	N/A	DWS F	ull Width?	N/A
N/A	Landing Curb? (Y/N)	N/A	N/A	DWS C	Offset (in)	N/A
N/A	Shared Landing?	N/A				
N/A	Gutter Ponding?	N/A	N/A	Gutter	Slope (%)	N/A
N/A	Gutter Lip Ht (in)	N/A	N/A	Gutter	X Slope (%)	N/A
N/A	Painted X Walk1?	No	N/A	Painted	I X Walk2?	N/A
	X Walk 1 Direction	To E		X Walk	2 Direction	N/A
N/A	X Walk 1 Width (in)	N/A	N/A	X Walk	2 Width (in)	N/A
	X Walk 1 Slope (%)	2.1		X Walk	2 Slope (%)	N/A
	X Walk 1 X Slope (%)	5.4		X Walk	2 X Slope (%)	N/A

N/A	Ramp inside XWalk1?	N/A	N/A	Ramp i	nside XWalk2?	N/A
	Road Slope (%)	N/A	N/A	Clear S	Space?	N/A
	Road X Slope (%)	N/A	N/A	Clear S	Space to XWalk (in)	N/A
N/A	Any Obstructions?	N/A	N/A	Storm (	Grate/Utility Hazard?	N/A
	Obstruction Type			Storm (	Grate/Utility Type	
		N/A				N/A
			Yes	Surface	e Condition? (G/P)	Good

Possible Solutions:	<u>c</u>		
Remove & Replace Entire Ramp.			
·	Υ		
	N		
	N		
	N		
	N		
Surveyor Notes:	N		
N/A	N		
	N		
	N		
	N		
PROW/ADA:	N		
Not Found, R304.2.2	N		
	N		
	N		
	N
