Access Compliance Report

Public Rights-of-Way

(Curb Ramps)

Intersection ID: 2500	Main Street: CAMBRIDGE_BAY_DR	Cross Street: VISCOUNT_LN	Location: NW
ADA ID: F0A118FBA4F1	Ramp Type: Perp	Initial Pass/Fail: Fail	Overall Compliance: No
Severity Score: 12.5			
Codes/Mitigation Info/Possible Solution		Field Measurements/Component Compliance

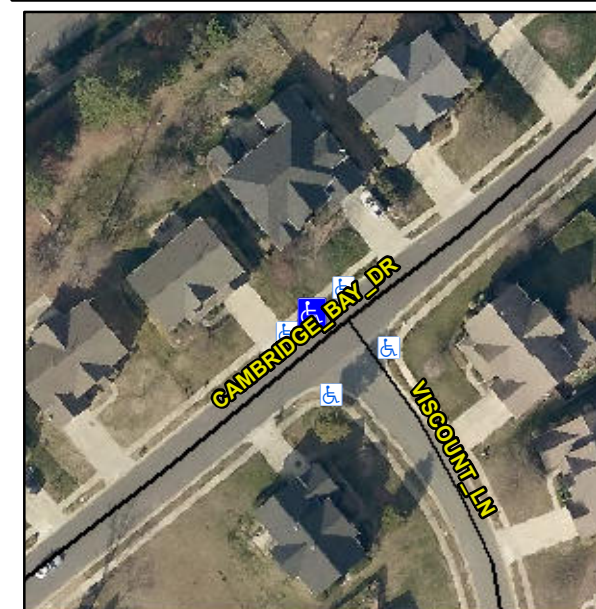
Not Found, R304.2.2

Compliance	Description	Data	Compliance	Description	Data
N/A	Ramp Length (in)	47.0	No	Ramp Slope (%)	11.1
Yes	Ramp Width (in)	48.0	Yes	Ramp XSlope (%)	1.4
N/A	Flare Type LT	N/A	N/A	Flare Type RT	N/A
N/A	Flare Slope LT (%)	N/A	N/A	Flare Slope RT (%)	N/A
N/A	Flare Traversable LT?	N/A	N/A	Flare Traversable RT?	N/A
N/A	Landing Length (in)	N/A	N/A	DWS Provided?	N/A
N/A	Landing Width (in)	N/A	N/A	DWS Contrast?	N/A
N/A	Landing Slope (%)	N/A	N/A	DWS Length (in)	N/A
N/A	Landing X Slope (%)	N/A	N/A	DWS Full Width?	N/A
N/A	Landing Curb? (Y/N)	N/A	N/A	DWS Offset (in)	N/A
N/A	Shared Landing?	N/A			
N/A	Gutter Ponding?	N/A	N/A	Gutter Slope (%)	N/A
N/A	Gutter Lip Ht (in)	N/A	N/A	Gutter X Slope (%)	N/A
N/A	Painted X Walk1?	No	N/A	Painted X Walk2?	N/A
	X Walk 1 Direction	To SE		X Walk 2 Direction	N/A
N/A	X Walk 1 Width (in)	N/A	N/A	X Walk 2 Width (in)	N/A
	X Walk 1 Slope (%)	3.9		X Walk 2 Slope (%)	N/A
	X Walk 1 X Slope (%)	0.4		X Walk 2 X Slope (%)	N/A

N/A	Ramp inside XWalk1?	N/A	N/A	Ramp inside XWalk2?	N/A
	Road Slope (%)	N/A	N/A	Clear Space?	N/A
	Road X Slope (%)	N/A	N/A	Clear Space to XWalk (in)	N/A
N/A	Any Obstructions?	N/A	N/A	Storm Grate/Utility Hazard?	N/A
	Obstruction Type			Storm Grate/Utility Type	
		N/A			N/A
			Yes	Surface Condition? (G/P)	Good

Possible Solutions:

Remove & Replace Entire Ramp.
