# Access Compliance Report

## Public Rights-of-Way

### (Curb Ramps)

| Intersection ID: 53351 | Main Street: MARVIN_RD | Cross Street: SAPPHIRE_HILL_LN | Location: SE |

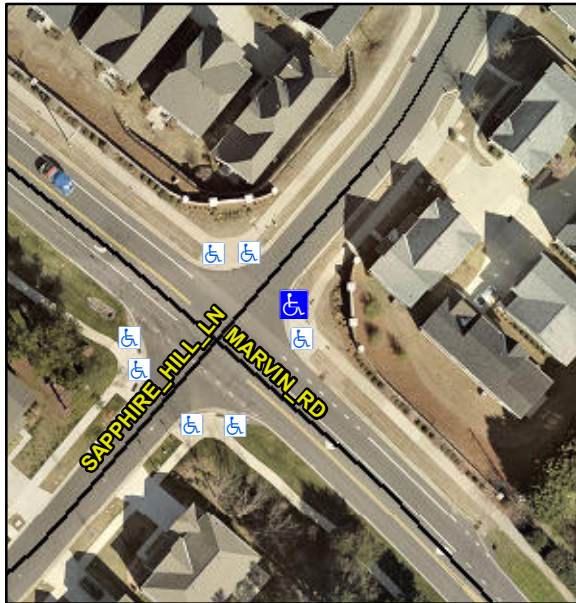
| ADA ID: F0A7E5527F88 | Ramp Type: BlendTrans2 | Initial Pass/Fail: Fail | Overall Compliance: No |
| | | Severity Score: 25 | |

**Remove & Replace Curb Ramp With Two New Directional Ramps or Equivalent.**

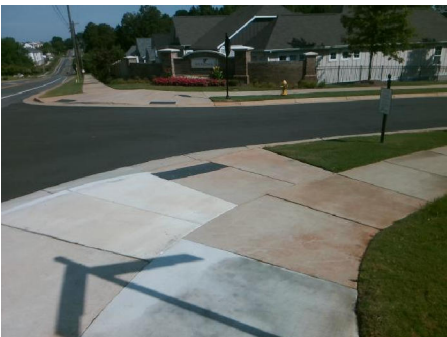
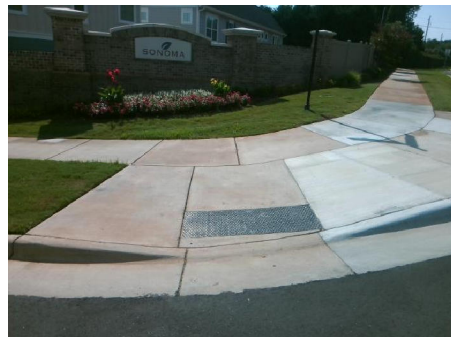
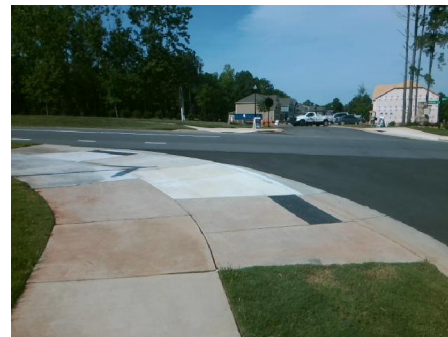
**Not Found, R304.5.3**

| Compliance | Description | Data | Compliance | Description | Data |
|---|---|---|---|---|---|
| Yes | Ramp Width (in) | 54.0 | No | BlendTrans XSlope (%) | 15.0 |
| | | | No | Curb Slope (%) | 7.0 |
