Access Compliance Report

Public Rights-of-Way

(Curb Ramps)

Intersection ID: 2970	Main Street: MADISON_PARK_DR	Cross Street: WOODFIRE_RD	Location:	S
ADA ID: F0AAD17B23B9	Ramp Type: Perp	Initial Pass/Fail: Fail	Overall Compliance: No	Severity Score: 25
Codes/Mitigation Info/Possible Solution		Field Measurements/Component Compliance

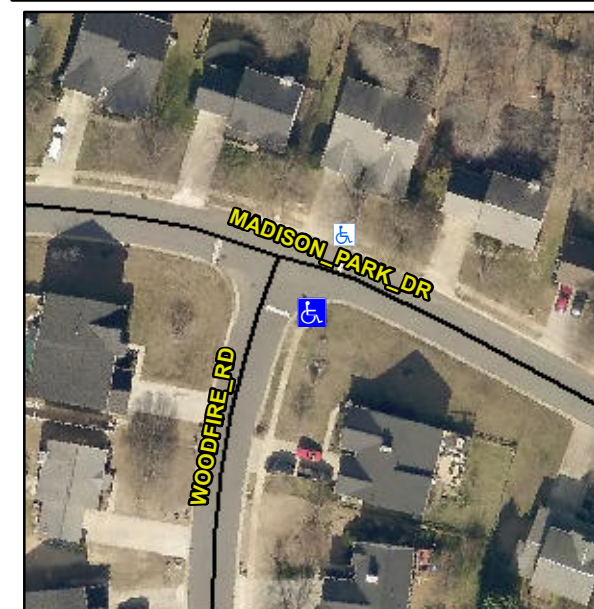
Not Found, R304.2.2, R304.5.3

Compliance	Description	Data	Compliance	Description	Data
N/A	Ramp Length (in)	46.0	No	Ramp Slope (%)	10.6
Yes	Ramp Width (in)	48.0	No	Ramp XSlope (%)	6.5
N/A	Flare Type LT	N/A	N/A	Flare Type RT	N/A
N/A	Flare Slope LT (%)	N/A	N/A	Flare Slope RT (%)	N/A
N/A	Flare Traversable LT?	N/A	N/A	Flare Traversable RT?	N/A
N/A	Landing Length (in)	N/A	N/A	DWS Provided?	N/A
N/A	Landing Width (in)	N/A	N/A	DWS Contrast?	N/A
N/A	Landing Slope (%)	N/A	N/A	DWS Length (in)	N/A
N/A	Landing X Slope (%)	N/A	N/A	DWS Full Width?	N/A
N/A	Landing Curb? (Y/N)	N/A	N/A	DWS Offset (in)	N/A
N/A	Shared Landing?	N/A			
N/A	Gutter Ponding?	N/A	N/A	Gutter Slope (%)	N/A
N/A	Gutter Lip Ht (in)	N/A	N/A	Gutter X Slope (%)	N/A
N/A	Painted X Walk1?	No	N/A	Painted X Walk2?	N/A
	X Walk 1 Direction	To NE		X Walk 2 Direction	N/A
N/A	X Walk 1 Width (in)	N/A	N/A	X Walk 2 Width (in)	N/A
	X Walk 1 Slope (%)	0.3		X Walk 2 Slope (%)	N/A
	X Walk 1 X Slope (%)	5.3		X Walk 2 X Slope (%)	N/A

N/A	Ramp inside XWalk1?	N/A	N/A	Ramp inside XWalk2?	N/A
	Road Slope (%)	N/A	N/A	Clear Space?	N/A
	Road X Slope (%)	N/A	N/A	Clear Space to XWalk (in)	N/A
N/A	Any Obstructions?	N/A	N/A	Storm Grate/Utility Hazard?	N/A
	Obstruction Type			Storm Grate/Utility Type	
		N/A			N/A
			Yes	Surface Condition? (G/P)	Good

Possible Solutions:

Remove & Replace Entire Ramp.

Total Cost: \$ 1850.00
