# Access Compliance Report

## Public Rights-of-Way

### (Curb Ramps)

| ADA ID: F0BFA71BB299 | Ramp Type: BlendTrans2 | Initial Pass/Fail: Fail | Overall Compliance: No |

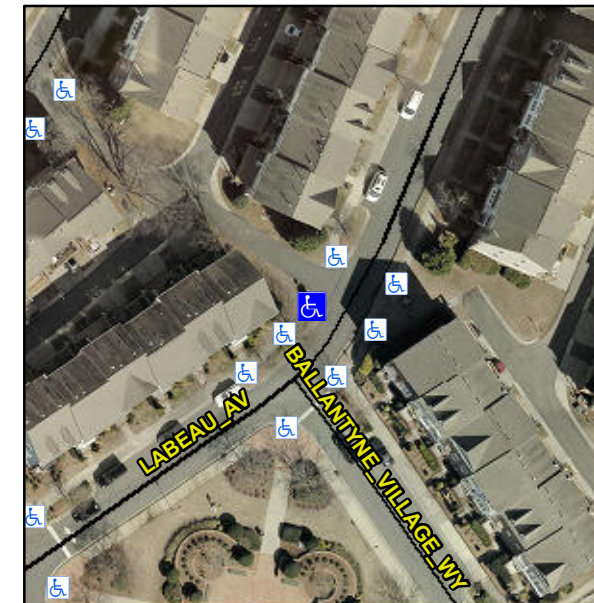
**CURB LIP 1.0**

**Not Found, R304.5.1, R304.5.3**

| Compliance | Description | Data | Compliance | Description | Data |
|---|---|---|---|---|---|
| No | Ramp Width (in) | 41.0 | No | BlendTrans XSlope (%) | 8.7 |

**Remove & Replace Curb Ramp With Two New Directional Ramps or Equivalent.**
