# Access Compliance Report

## Public Rights-of-Way

### (Curb Ramps)

Intersection ID: 9836	Main Street: ANDRILL_TR	Cross Street: WASHINGTON_AV	Location: SW
ADA ID: F0C06A352D67	Ramp Type: BlendTrans2	Initial Pass/Fail: Fail	Overall Compliance: No
		Severity Score: 10

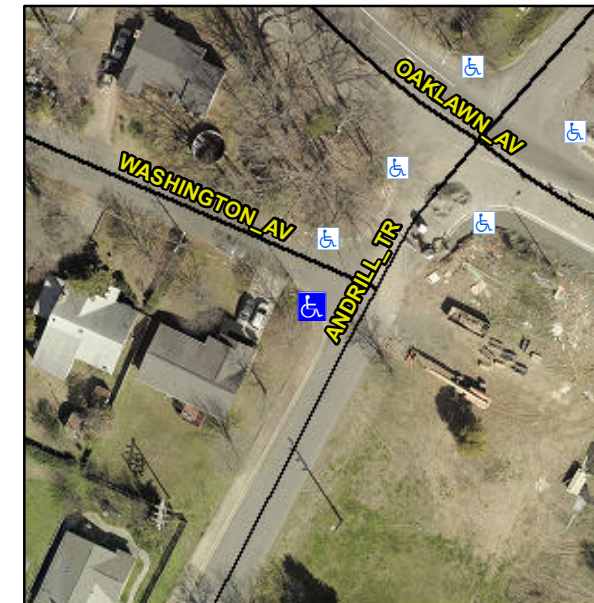
#### Field Measurements/Component Compliance

Compliance	Description	Data	Compliance	Description	Data
N/A	Ramp Length (in)	72.0	Yes	BlendTrans Slope (%)	4.6
No	Ramp Width (in)	43.0	No	BlendTrans XSlope (%)	4.1
N/A	Flare Type LT	N/A	N/A	Flare Type RT	N/A
N/A	Flare Slope LT (%)	N/A	N/A	Flare Slope RT (%)	N/A
N/A	Flare Traversable LT?	N/A	N/A	Flare Traversable RT?	N/A
N/A	Landing Length (in)	N/A	N/A	DWS Provided?	N/A
N/A	Landing Width (in)	N/A	N/A	DWS Contrast?	N/A
N/A	Landing Slope (%)	N/A	N/A	DWS Length (in)	N/A
N/A	Landing X Slope (%)	N/A	N/A	DWS Full Width?	N/A
N/A	Landing Curb? (Y/N)	N/A	N/A	DWS Offset (in)	N/A
N/A	Shared Landing?	N/A			
N/A	Gutter Ponding?	N/A	N/A	Gutter Slope (%)	N/A
N/A	Gutter Lip Ht (in)	N/A	N/A	Gutter X Slope (%)	N/A
N/A	Painted X Walk1?	No	N/A	Painted X Walk2?	N/A
	X Walk 1 Direction	To NE		X Walk 2 Direction	N/A
	X Walk 1 Width (in)	N/A		X Walk 2 Width (in)	N/A
	X Walk 1 Slope (%)	4.6		X Walk 2 Slope (%)	N/A
	X Walk 1 X Slope (%)	0.8		X Walk 2 X Slope (%)	N/A

N/A	Ramp inside XWalk1?	N/A	N/A	Ramp inside XWalk2?	N/A
	Road Slope (%)	0.8		Clear Space?	N/A
	Road X Slope (%)	4.6	N/A	Clear Space to XWalk (in)	N/A
N/A	Any Obstructions?	N/A	N/A	Storm Grate/Utility Hazard?	N/A
	Obstruction Type			Storm Grate/Utility Type	
		N/A			N/A
			Yes	Surface Condition? (G/P)	Good
			No	Curb Slope (%)	11.4

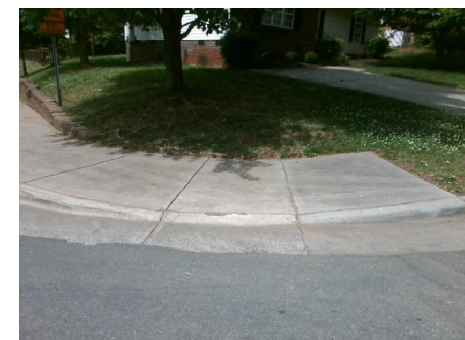
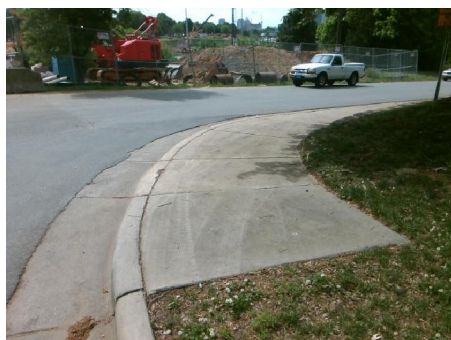
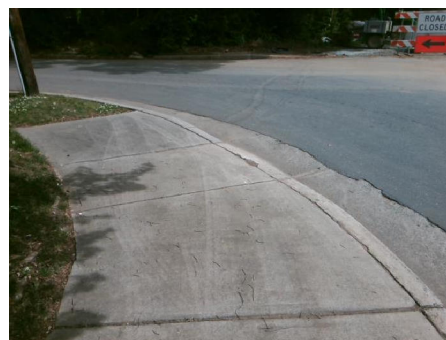
**CURB GAP 3.5, CURB LIP 1.0, NO RT SW**

**Not Found, R304.5.1, R304.5.3**

**Remove & Replace Curb Ramp With Two New Directional Ramps or Equivalent.**
