## **Access Compliance Report Public Rights-of-Way** (Curb Ramps)

Intersection ID: 13590 Main Street: CAMDEN RD **Cross Street: S TRYON ST** Location: NE ADA ID: F0C6A7F699AB Ramp Type: Perp Initial Pass/Fail: Fail **Overall Compliance: No Severity Score:** 12.5

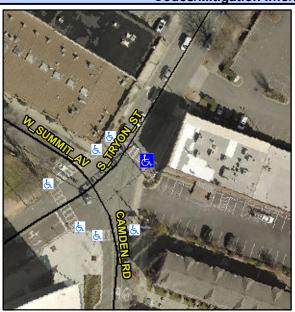
Possible Solution		Field Me
Possible Solutions:	Compl	iance Description
Remove & Replace Entire Ramp.	N/A	Ramp Length (in)
·	Yes	Ramp Width (in)
	N/A	Flare Type LT
	N/A	Flare Slope LT (%)
	N/A	Flare Traversable LT
	N/A	Landing Length (in)
Surveyor Notes:	N/A	Landing Width (in)
N/A	N/A	Landing Slope (%)
	N/A	Landing X Slope (%)
	N/A	Landing Curb? (Y/N)
	N/A	Shared Landing?
PROW/ADA:	N/A	Gutter Ponding?
R304.5.3	N/A	Gutter Lip Ht (in)
	N/A	Painted X Walk1?
		X Walk 1 Direction
	N/A	X Walk 1 Width (in)
		X Walk 1 Slope (%)
		X Walk 1 X Slope (%
	N/A	Ramp inside XWalk1
		Road Slone (%)

Road X Slope (%)	N/A	N/A	Clear Space to XWalk (in)	N/A	Ĺ
				N/A	Any Obstructions?	N/A	N/A	Storm Grate/Utility Hazard?	N/A	ı.
	٦	Total Cost:	\$ 1850.00		Obstruction Type			Storm Grate/Utility Type		
						N/A			N/A	L
							Yes	Surface Condition? (G/P)	Good	l
			atter to	tw! Allf		·	-
