# Access Compliance Report

## Public Rights-of-Way (Curb Ramps)

Intersection ID: 10019721	Main Street: ANNAHILL_CT	Cross Street: N/A	Location: NW
ADA ID: F0C76BB4A78B	Ramp Type: BlendTrans1	Initial Pass/Fail: Fail	Overall Compliance: No
Severity Score: 21.25			
Codes/Mitigation Info/Possible Solution		Field Measurements/Component Compliance

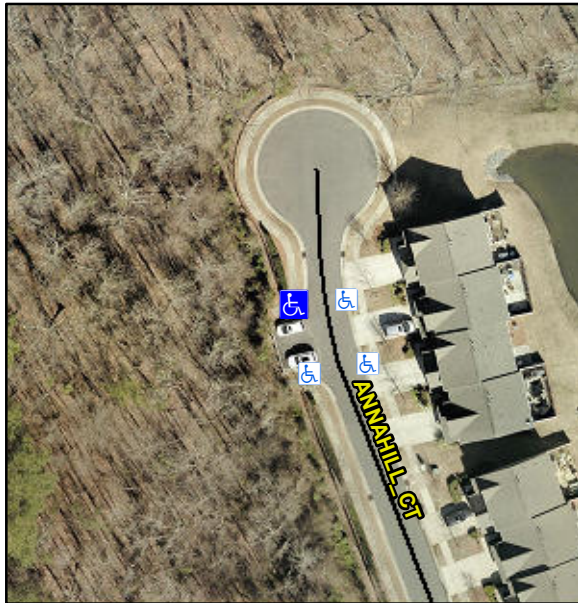
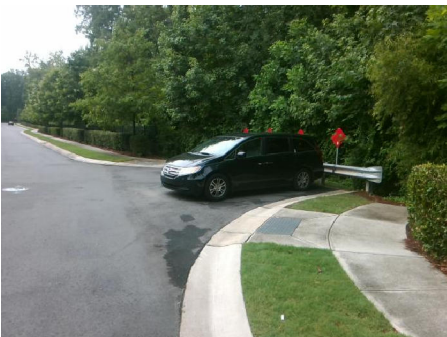
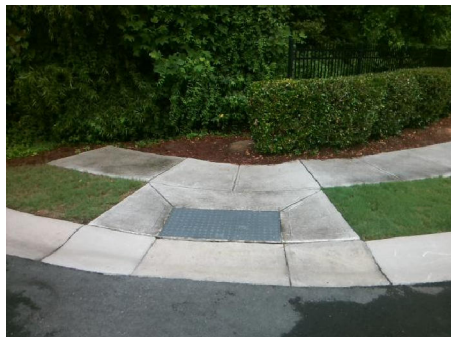
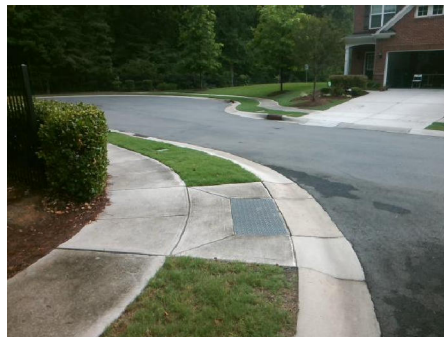
Compliance	Description	Data	Compliance	Description	Data
N/A	Ramp Length (in)	47.0	Yes	BlendTrans Slope (%)	4.5
No	Ramp Width (in)	47.5	No	BlendTrans XSlope (%)	6.2
N/A	Flare Type LT	N/A	N/A	Flare Type RT	N/A
N/A	Flare Slope LT (%)	N/A	N/A	Flare Slope RT (%)	N/A
N/A	Flare Traversable LT?	N/A	N/A	Flare Traversable RT?	N/A
N/A	Landing Length (in)	N/A	N/A	DWS Provided?	N/A
N/A	Landing Width (in)	N/A	N/A	DWS Contrast?	N/A
N/A	Landing Slope (%)	N/A	N/A	DWS Length (in)	N/A
N/A	Landing X Slope (%)	N/A	N/A	DWS Full Width?	N/A
N/A	Landing Curb? (Y/N)	N/A	N/A	DWS Offset (in)	N/A
N/A	Shared Landing?	N/A			
N/A	Gutter Ponding?	N/A	N/A	Gutter Slope (%)	N/A
N/A	Gutter Lip Ht (in)	N/A	N/A	Gutter X Slope (%)	N/A
N/A	Painted X Walk1?	No	N/A	Painted X Walk2?	No
	X Walk 1 Direction	To S		X Walk 2 Direction	To E
	X Walk 1 Width (in)	N/A		X Walk 2 Width (in)	N/A
	X Walk 1 Slope (%)	1.4		X Walk 2 Slope (%)	0.9
	X Walk 1 X Slope (%)	1.5		X Walk 2 X Slope (%)	1.2

N/A	Ramp inside XWalk1?	N/A	N/A	Ramp inside XWalk2?	N/A
	Road Slope (%)	1.6		Clear Space?	N/A
	Road X Slope (%)	0.2	N/A	Clear Space to XWalk (in)	N/A
N/A	Any Obstructions?	N/A	N/A	Storm Grate/Utility Hazard?	N/A
	Obstruction Type			Storm Grate/Utility Type	
		N/A			N/A
			Yes	Surface Condition? (G/P)	Good
			N/A	Curb Slope (%)	3.9

**Remove & Replace Curb Ramp With Two New Directional Ramps or Equivalent.**

Total Cost: \$ 3200.00
