Access Compliance Report

Public Rights-of-Way

(Curb Ramps)

Intersection ID: N/A	Main Street: HICKORY GROVE RD	Cross Street: LAWRENCE ORR RD	Location: NE
ADA ID: F0CF95CA0B8D	Ramp Type: PerpDiag	Initial Pass/Fail: Fail	Overall Compliance: No
Severity Score: 13.75			
Codes/Mitigation Info/Possible Solution		Field Measurements/Component Compliance

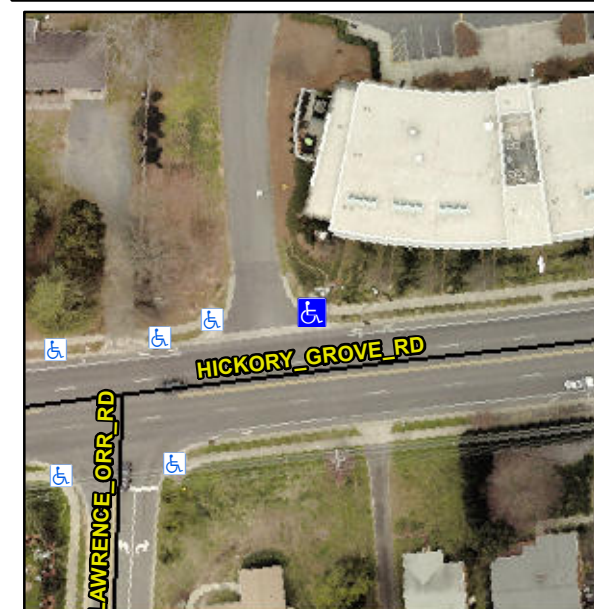
Compliance	Description	Data	Compliance	Description	Data
N/A	Ramp Length (in)	47.5	No	Ramp Slope (%)	10.2
Yes	Ramp Width (in)	48.0	No	Ramp XSlope (%)	3.5
N/A	Flare Type LT	N/A	N/A	Flare Type RT	N/A
N/A	Flare Slope LT (%)	N/A	N/A	Flare Slope RT (%)	N/A
N/A	Flare Traversable LT?	N/A	N/A	Flare Traversable RT?	N/A
N/A	Landing Length (in)	N/A	N/A	DWS Provided?	N/A
N/A	Landing Width (in)	N/A	N/A	DWS Contrast?	N/A
N/A	Landing Slope (%)	N/A	N/A	DWS Length (in)	N/A
N/A	Landing X Slope (%)	N/A	N/A	DWS Full Width?	N/A
N/A	Landing Curb? (Y/N)	N/A	N/A	DWS Offset (in)	N/A
N/A	Shared Landing?	N/A			
N/A	Gutter Ponding?	N/A	N/A	Gutter Slope (%)	N/A
N/A	Gutter Lip Ht (in)	N/A	N/A	Gutter X Slope (%)	N/A
N/A	Painted X Walk1?	No	N/A	Painted X Walk2?	No
	X Walk 1 Direction	To W		X Walk 2 Direction	To S
N/A	X Walk 1 Width (in)	N/A	N/A	X Walk 2 Width (in)	N/A
	X Walk 1 Slope (%)	1.4		X Walk 2 Slope (%)	4.2
	X Walk 1 X Slope (%)	7.9		X Walk 2 X Slope (%)	1.4

N/A	Ramp inside XWalk1?	N/A	N/A	Ramp inside XWalk2?	N/A
	Road Slope (%)	5.0	N/A	Clear Space?	N/A
	Road X Slope (%)	4.5	N/A	Clear Space to XWalk (in)	N/A
N/A	Any Obstructions?	N/A	N/A	Storm Grate/Utility Hazard?	N/A
	Obstruction Type			Storm Grate/Utility Type	
		N/A			N/A
		Yes		Surface Condition? (G/P)	Good

Possible Solutions:

Remove & Replace Curb Ramp With Two New Directional Ramps or Equivalent.
