Access Compliance Report

Public Rights-of-Way

(Curb Ramps)

Intersection ID: 23437	Main Street: TRYON_ST	Cross Street: MOSS_LN	Location: W
ADA ID: F0D56C621614	Ramp Type: MedianPerp	Initial Pass/Fail: Fail	Overall Compliance: No
Severity Score: 12.5			
Codes/Mitigation Info/Possible Solution		Field Measurements/Component Compliance

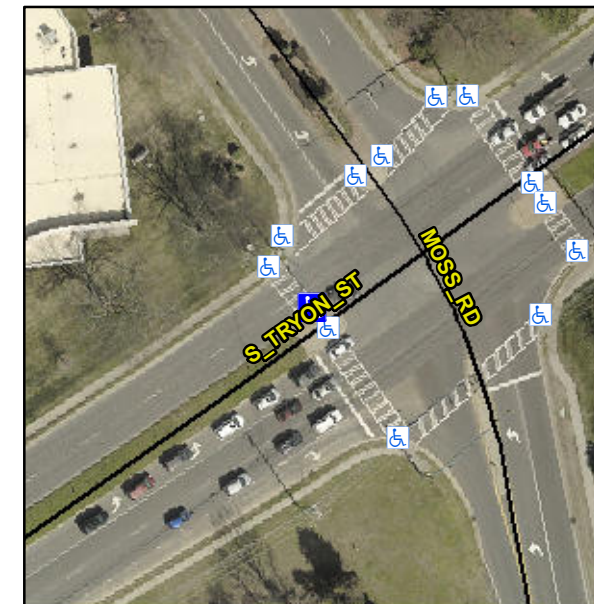
Not Found, R304.2.2

Compliance	Description	Data	Compliance	Description	Data
N/A	Ramp Length (in)	72.0	No	Ramp Slope (%)	9.0
Yes	Ramp Width (in)	48.0	Yes	Ramp XSlope (%)	1.1
N/A	Flare Type LT	N/A	N/A	Flare Type RT	N/A
N/A	Flare Slope LT (%)	N/A	N/A	Flare Slope RT (%)	N/A
N/A	Flare Traversable LT?	N/A	N/A	Flare Traversable RT?	N/A
N/A	Landing Length (in)	N/A	N/A	DWS Provided?	N/A
N/A	Landing Width (in)	N/A	N/A	DWS Contrast?	N/A
N/A	Landing Slope (%)	N/A	N/A	DWS Length (in)	N/A
N/A	Landing X Slope (%)	N/A	N/A	DWS Full Width?	N/A
N/A	Landing Curb? (Y/N)	N/A	N/A	DWS Offset (in)	N/A
N/A	Shared Landing?	N/A			
N/A	Gutter Ponding?	N/A	N/A	Gutter Slope (%)	N/A
N/A	Gutter Lip Ht (in)	N/A	N/A	Gutter X Slope (%)	N/A
N/A	Painted X Walk1?	Yes	N/A	Painted X Walk2?	N/A
	X Walk 1 Direction	To N		X Walk 2 Direction	N/A
N/A	X Walk 1 Width (in)	118.0	N/A	X Walk 2 Width (in)	N/A
	X Walk 1 Slope (%)	1.3		X Walk 2 Slope (%)	N/A
	X Walk 1 X Slope (%)	1.4		X Walk 2 X Slope (%)	N/A

N/A	Ramp inside XWalk1?	Yes	N/A	Ramp inside XWalk2?	N/A
	Road Slope (%)	N/A	N/A	Clear Space?	N/A
	Road X Slope (%)	N/A	N/A	Clear Space to XWalk (in)	N/A
N/A	Any Obstructions?	N/A	N/A	Storm Grate/Utility Hazard?	N/A
	Obstruction Type			Storm Grate/Utility Type	
		N/A			N/A
		Yes		Surface Condition? (G/P)	Good

Possible Solutions:

Remove & Replace Entire Ramp.
