# Access Compliance Report

## Public Rights-of-Way

Intersection ID: 48604	Main Street: S_TRYON_ST	Cross Street: LITTLE_GEM_LN	Location: NE
ADA ID: F0D853FC1934	Ramp Type: Perp	Initial Pass/Fail: Fail	Overall Compliance: No
Severity Score: 21.25			
Codes/Mitigation Info/Possible Solution		Field Measurements/Component Compliance

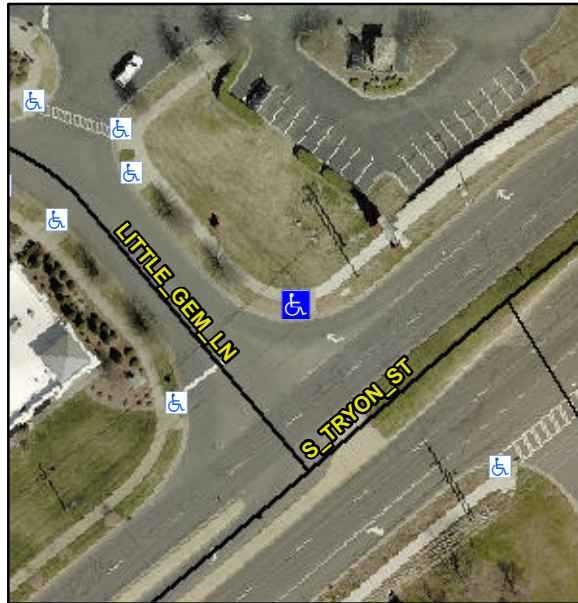
Compliance	Description	Data	Compliance	Description	Data
N/A	Ramp Length (in)	98.0	No	Ramp Slope (%)	9.0
No	Ramp Width (in)	46.0	Yes	Ramp XSlope (%)	2.0
N/A	Flare Type LT	N/A	N/A	Flare Type RT	N/A
N/A	Flare Slope LT (%)	N/A	N/A	Flare Slope RT (%)	N/A
N/A	Flare Traversable LT?	N/A	N/A	Flare Traversable RT?	N/A
N/A	Landing Length (in)	N/A	N/A	DWS Provided?	N/A
N/A	Landing Width (in)	N/A	N/A	DWS Contrast?	N/A
N/A	Landing Slope (%)	N/A	N/A	DWS Length (in)	N/A
N/A	Landing X Slope (%)	N/A	N/A	DWS Full Width?	N/A
N/A	Landing Curb? (Y/N)	N/A	N/A	DWS Offset (in)	N/A
N/A	Shared Landing?	N/A			
N/A	Gutter Ponding?	N/A	N/A	Gutter Slope (%)	N/A
N/A	Gutter Lip Ht (in)	N/A	N/A	Gutter X Slope (%)	N/A
N/A	Painted X Walk1?	No	N/A	Painted X Walk2?	N/A
	X Walk 1 Direction	To SW		X Walk 2 Direction	N/A
N/A	X Walk 1 Width (in)	N/A	N/A	X Walk 2 Width (in)	N/A
	X Walk 1 Slope (%)	0.7		X Walk 2 Slope (%)	N/A
	X Walk 1 X Slope (%)	3.0		X Walk 2 X Slope (%)	N/A

N/A	Ramp inside XWalk1?	N/A	N/A	Ramp inside XWalk2?	N/A
	Road Slope (%)	N/A	N/A	Clear Space?	N/A
	Road X Slope (%)	N/A	N/A	Clear Space to XWalk (in)	N/A
N/A	Any Obstructions?	N/A	N/A	Storm Grate/Utility Hazard?	N/A
	Obstruction Type			Storm Grate/Utility Type	
		N/A			N/A
			Yes	Surface Condition? (G/P)	Good

**Remove & Replace Entire Ramp.**

**R304.5.1, R304.2.2**

Total Cost: \$ 1850.00
