Access Compliance Report

Public Rights-of-Way

(Curb Ramps)

Intersection ID: 30238	Main Street: BLUE_TOPAZ_CT	Cross Street: SILVER_ORE_LN	Location: SE
ADA ID: F0DE66EE84F1	Ramp Type: Perp	Initial Pass/Fail: Fail	Overall Compliance: No Severity Score: 33.75

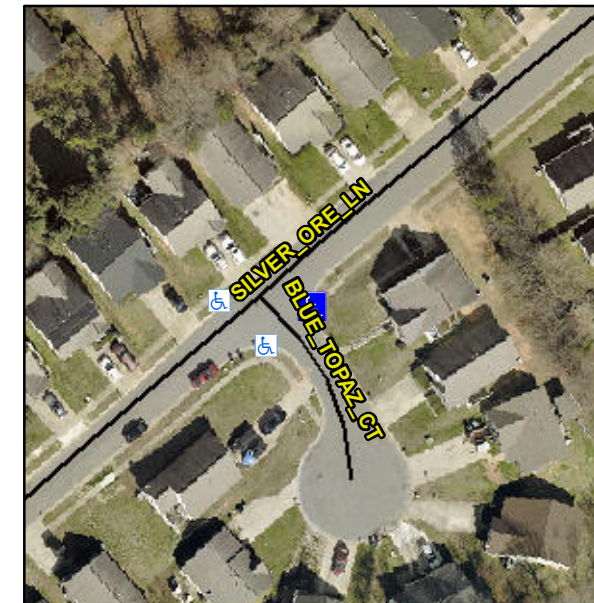
Not Found, R304.5.1, R304.5.3

Compliance	Description	Data	Compliance	Description	Data
N/A	Ramp Length (in)	59.0	Yes	Ramp Slope (%)	5.9
No	Ramp Width (in)	44.0	No	Ramp XSlope (%)	10.3
N/A	Flare Type LT	N/A	N/A	Flare Type RT	N/A
N/A	Flare Slope LT (%)	N/A	N/A	Flare Slope RT (%)	N/A
N/A	Flare Traversable LT?	N/A	N/A	Flare Traversable RT?	N/A
N/A	Landing Length (in)	N/A	N/A	DWS Provided?	N/A
N/A	Landing Width (in)	N/A	N/A	DWS Contrast?	N/A
N/A	Landing Slope (%)	N/A	N/A	DWS Length (in)	N/A
N/A	Landing X Slope (%)	N/A	N/A	DWS Full Width?	N/A
N/A	Landing Curb? (Y/N)	N/A	N/A	DWS Offset (in)	N/A
N/A	Shared Landing?	N/A			
N/A	Gutter Ponding?	N/A	N/A	Gutter Slope (%)	N/A
N/A	Gutter Lip Ht (in)	N/A	N/A	Gutter X Slope (%)	N/A
N/A	Painted X Walk1?	No	N/A	Painted X Walk2?	N/A
	X Walk 1 Direction	To SW		X Walk 2 Direction	N/A
N/A	X Walk 1 Width (in)	N/A	N/A	X Walk 2 Width (in)	N/A
	X Walk 1 Slope (%)	1.9		X Walk 2 Slope (%)	N/A
	X Walk 1 X Slope (%)	4.4		X Walk 2 X Slope (%)	N/A

N/A	Ramp inside XWalk1?	N/A	N/A	Ramp inside XWalk2?	N/A
	Road Slope (%)	N/A	N/A	Clear Space?	N/A
	Road X Slope (%)	N/A	N/A	Clear Space to XWalk (in)	N/A
N/A	Any Obstructions?	N/A	N/A	Storm Grate/Utility Hazard?	N/A
	Obstruction Type			Storm Grate/Utility Type	
		N/A			N/A
			Yes	Surface Condition? (G/P)	Good

Remove & Replace Entire Ramp.
