Access Compliance Report

Public Rights-of-Way

(Curb Ramps)

Intersection ID: 10015016	Main Street: WILORA_LAKE_RD	Cross Street: N/A	Location: SW
ADA ID: F0E2E3B7DACF	Ramp Type: Perp	Initial Pass/Fail: Fail	Overall Compliance: No
			Severity Score: 12.5

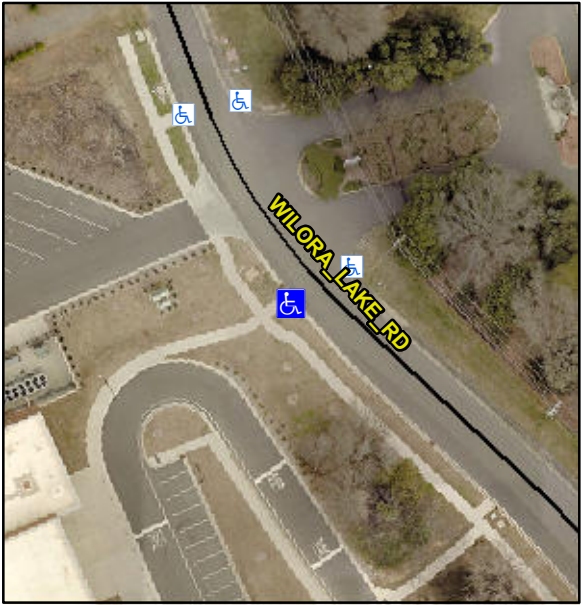
Possible Solutions:		Compliance	Description	Data
	Remove & Replace Entire Ramp.		No	Ramp Length (in)	98.0
			Yes	Ramp Width (in)	59.0
			N/A	Flare Type LT	N/A
			N/A	Flare Slope LT (%)	N/A
			N/A	Flare Traversable LT?	N/A
			N/A	Landing Length (in)	N/A
			N/A	Landing Width (in)	N/A
			N/A	Landing Slope (%)	N/A
			N/A	Landing X Slope (%)	N/A
<p>Surveyor Notes:</p> <p>N/A</p> <p>PROW/ADA:</p> <p>Not Found, R304.2.2</p>			N/A	Flare Type RT	N/A
			N/A	Flare Slope RT (%)	N/A
			N/A	Flare Traversable RT?	N/A
			N/A	DWS Provided?	N/A
			N/A	DWS Contrast?	N/A
			N/A	DWS Length (in)	N/A
			N/A	DWS Full Width?	N/A
			N/A	DWS Offset (in)	N/A
			N/A	Shared Landing?	N/A
			N/A	Gutter Ponding?	N/A
			N/A	Gutter Lip Ht (in)	N/A
			N/A	Painted X Walk1?	No
				X Walk 1 Direction	To E
			N/A	X Walk 1 Width (in)	N/A
				X Walk 1 Slope (%)	1.8
				X Walk 1 X Slope (%)	0.1
