Access Compliance Report

Public Rights-of-Way

(Curb Ramps)

Intersection ID: 32022	Main Street: FAIRWAY_VISTA_DR	Cross Street: GREENWAY_BEND_DR	Location: E
ADA ID: F0E86400B8AE	Ramp Type: PerpDiag	Initial Pass/Fail: Fail	Overall Compliance: No
Severity Score: 46.25			
Codes/Mitigation Info/Possible Solution		Field Measurements/Component Compliance

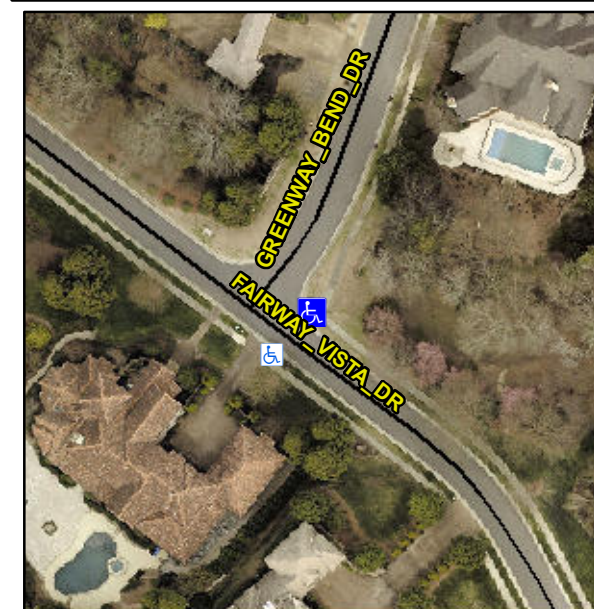
Not Found, R304.5.1, R304.2.2, R304.5.3

Compliance	Description	Data	Compliance	Description	Data
N/A	Ramp Length (in)	64.0	No	Ramp Slope (%)	8.8
No	Ramp Width (in)	37.0	No	Ramp XSlope (%)	9.2
N/A	Flare Type LT	N/A	N/A	Flare Type RT	N/A
N/A	Flare Slope LT (%)	N/A	N/A	Flare Slope RT (%)	N/A
N/A	Flare Traversable LT?	N/A	N/A	Flare Traversable RT?	N/A
N/A	Landing Length (in)	N/A	N/A	DWS Provided?	N/A
N/A	Landing Width (in)	N/A	N/A	DWS Contrast?	N/A
N/A	Landing Slope (%)	N/A	N/A	DWS Length (in)	N/A
N/A	Landing X Slope (%)	N/A	N/A	DWS Full Width?	N/A
N/A	Landing Curb? (Y/N)	N/A	N/A	DWS Offset (in)	N/A
N/A	Shared Landing?	N/A			
N/A	Gutter Ponding?	N/A	N/A	Gutter Slope (%)	N/A
N/A	Gutter Lip Ht (in)	N/A	N/A	Gutter X Slope (%)	N/A
N/A	Painted X Walk1?	No	N/A	Painted X Walk2?	No
	X Walk 1 Direction	To NW		X Walk 2 Direction	To SW
N/A	X Walk 1 Width (in)	N/A	N/A	X Walk 2 Width (in)	N/A
	X Walk 1 Slope (%)	0.7		X Walk 2 Slope (%)	4.7
	X Walk 1 X Slope (%)	7.2		X Walk 2 X Slope (%)	8.3

N/A	Ramp inside XWalk1?	N/A	N/A	Ramp inside XWalk2?	N/A
	Road Slope (%)	9.8	N/A	Clear Space?	N/A
	Road X Slope (%)	2.8	N/A	Clear Space to XWalk (in)	N/A
N/A	Any Obstructions?	N/A	N/A	Storm Grate/Utility Hazard?	N/A
	Obstruction Type			Storm Grate/Utility Type	
		N/A			N/A
			Yes	Surface Condition? (G/P)	Good

Remove & Replace Curb Ramp With Two New Directional Ramps or Equivalent.
