Access Compliance Report

Public Rights-of-Way

(Curb Ramps)

Intersection ID: 13184	Main Street: S_MINT_ST	Cross Street: S_MINT_ST	Location: NW
ADA ID: F0E8BDBEA9F0	Ramp Type: PerpDiag	Initial Pass/Fail: Fail	Overall Compliance: No
Severity Score: 21.25			
Codes/Mitigation Info/Possible Solution		Field Measurements/Component Compliance

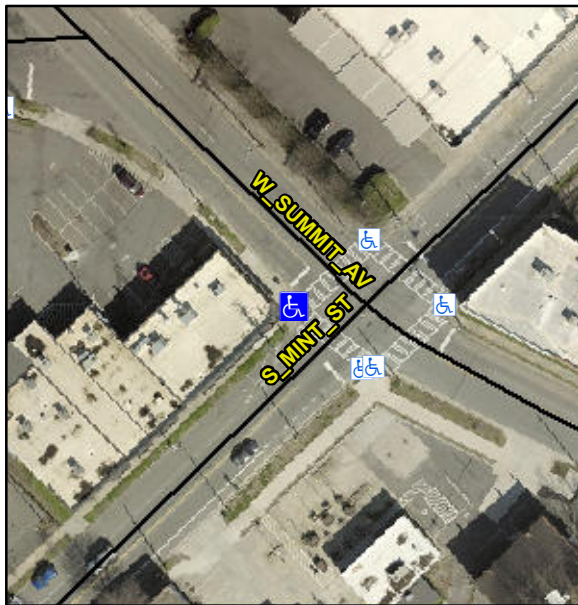
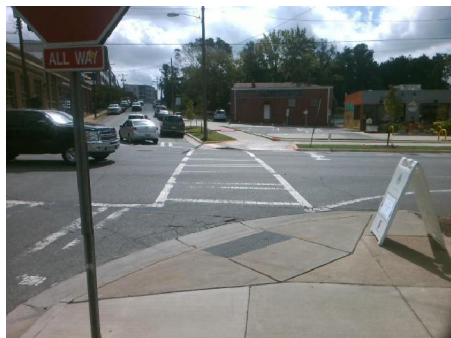
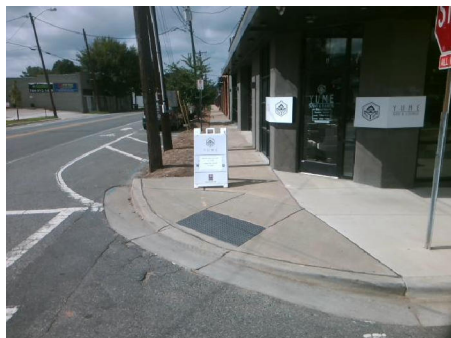
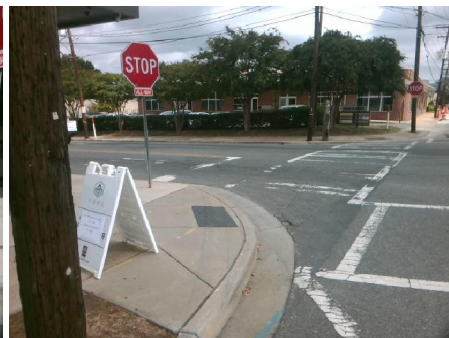
Not Found, R304.5.1, R304.2.2

Compliance	Description	Data	Compliance	Description	Data
N/A	Ramp Length (in)	64.0	No	Ramp Slope (%)	11.4
No	Ramp Width (in)	47.0	Yes	Ramp XSlope (%)	0.8
N/A	Flare Type LT	N/A	N/A	Flare Type RT	N/A
N/A	Flare Slope LT (%)	N/A	N/A	Flare Slope RT (%)	N/A
N/A	Flare Traversable LT?	N/A	N/A	Flare Traversable RT?	N/A
N/A	Landing Length (in)	N/A	N/A	DWS Provided?	N/A
N/A	Landing Width (in)	N/A	N/A	DWS Contrast?	N/A
N/A	Landing Slope (%)	N/A	N/A	DWS Length (in)	N/A
N/A	Landing X Slope (%)	N/A	N/A	DWS Full Width?	N/A
N/A	Landing Curb? (Y/N)	N/A	N/A	DWS Offset (in)	N/A
N/A	Shared Landing?	N/A			
N/A	Gutter Ponding?	N/A	N/A	Gutter Slope (%)	N/A
N/A	Gutter Lip Ht (in)	N/A	N/A	Gutter X Slope (%)	N/A
N/A	Painted X Walk1?	Yes	N/A	Painted X Walk2?	Yes
	X Walk 1 Direction	To SE		X Walk 2 Direction	To NE
N/A	X Walk 1 Width (in)	108.0	N/A	X Walk 2 Width (in)	108.0
	X Walk 1 Slope (%)	4.7		X Walk 2 Slope (%)	3.3
	X Walk 1 X Slope (%)	2.7		X Walk 2 X Slope (%)	5.2

N/A	Ramp inside XWalk1?	Yes	N/A	Ramp inside XWalk2?	Yes
	Road Slope (%)	0.5	N/A	Clear Space?	N/A
	Road X Slope (%)	4.2	N/A	Clear Space to XWalk (in)	N/A
N/A	Any Obstructions?	N/A	N/A	Storm Grate/Utility Hazard?	N/A
	Obstruction Type			Storm Grate/Utility Type	
		N/A			N/A
		Yes		Surface Condition? (G/P)	Good

Remove & Replace Curb Ramp With Two New Directional Ramps or Equivalent.
