Access Compliance Report

Public Rights-of-Way

(Curb Ramps)

Intersection ID: 43349	Main Street: FORESTRIDGE COMMONS DR	Cross Street: FORESTRIDGE COMMONS DR	Location: SW
ADA ID: F0F5B1C1AAEA	Ramp Type: PerpDiag	Initial Pass/Fail: Fail	Overall Compliance: No
Severity Score: 21.25			
Codes/Mitigation Info/Possible Solution		Field Measurements/Component Compliance

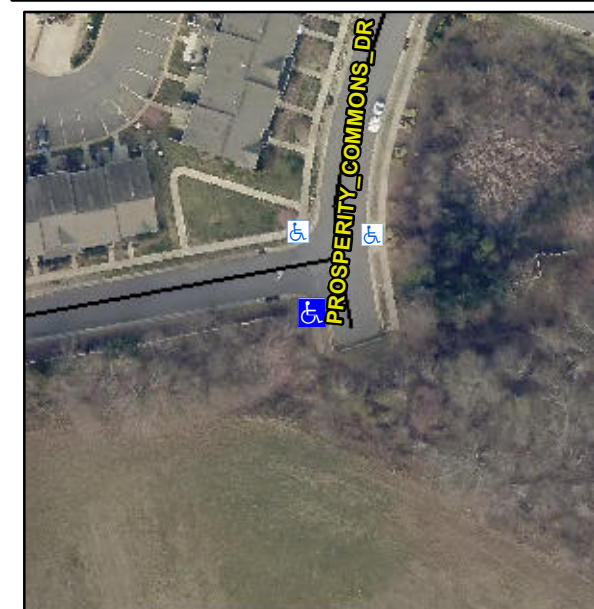
Compliance	Description	Data	Compliance	Description	Data
N/A	Ramp Length (in)	47.0	No	Ramp Slope (%)	10.2
No	Ramp Width (in)	40.0	Yes	Ramp XSlope (%)	1.9
N/A	Flare Type LT	N/A	N/A	Flare Type RT	N/A
N/A	Flare Slope LT (%)	N/A	N/A	Flare Slope RT (%)	N/A
N/A	Flare Traversable LT?	N/A	N/A	Flare Traversable RT?	N/A
N/A	Landing Length (in)	N/A	N/A	DWS Provided?	N/A
N/A	Landing Width (in)	N/A	N/A	DWS Contrast?	N/A
N/A	Landing Slope (%)	N/A	N/A	DWS Length (in)	N/A
N/A	Landing X Slope (%)	N/A	N/A	DWS Full Width?	N/A
N/A	Landing Curb? (Y/N)	N/A	N/A	DWS Offset (in)	N/A
N/A	Shared Landing?	N/A			
N/A	Gutter Ponding?	N/A	N/A	Gutter Slope (%)	N/A
N/A	Gutter Lip Ht (in)	N/A	N/A	Gutter X Slope (%)	N/A
N/A	Painted X Walk1?	No	N/A	Painted X Walk2?	No
	X Walk 1 Direction	To N		X Walk 2 Direction	To E
N/A	X Walk 1 Width (in)	N/A	N/A	X Walk 2 Width (in)	N/A
	X Walk 1 Slope (%)	0.7		X Walk 2 Slope (%)	2.1
	X Walk 1 X Slope (%)	0.8		X Walk 2 X Slope (%)	0.2

N/A	Ramp inside XWalk1?	N/A	N/A	Ramp inside XWalk2?	N/A
	Road Slope (%)	0.8	N/A	Clear Space?	N/A
	Road X Slope (%)	1.4	N/A	Clear Space to XWalk (in)	N/A
N/A	Any Obstructions?	N/A	N/A	Storm Grate/Utility Hazard?	N/A
	Obstruction Type			Storm Grate/Utility Type	
		N/A			N/A
			Yes	Surface Condition? (G/P)	Good

Possible Solutions:

Remove & Replace Curb Ramp With Two New Directional Ramps or Equivalent.

R304.5.1, R304.2.2

Total Cost: \$ 3200.00
