Access Compliance Report

Public Rights-of-Way

(Curb Ramps)

Intersection ID: 46725	Main Street: FAWN_VIEW_DR	Cross Street: HAMILTON_FOREST_DR	Location: SE
ADA ID: F0F8C696DC08	Ramp Type: Perp	Initial Pass/Fail: Fail	Overall Compliance: No
		Severity Score: 12.5

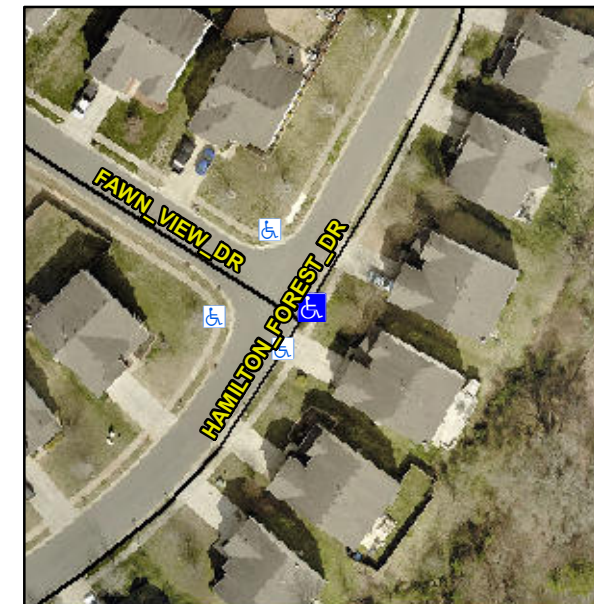
Not Found, R304.2.2

Compliance	Description	Data	Compliance	Description	Data
N/A	Ramp Length (in)	46.5	No	Ramp Slope (%)	9.1
Yes	Ramp Width (in)	48.0	Yes	Ramp XSlope (%)	1.9
N/A	Flare Type LT	N/A	N/A	Flare Type RT	N/A
N/A	Flare Slope LT (%)	N/A	N/A	Flare Slope RT (%)	N/A
N/A	Flare Traversable LT?	N/A	N/A	Flare Traversable RT?	N/A
N/A	Landing Length (in)	N/A	N/A	DWS Provided?	N/A
N/A	Landing Width (in)	N/A	N/A	DWS Contrast?	N/A
N/A	Landing Slope (%)	N/A	N/A	DWS Length (in)	N/A
N/A	Landing X Slope (%)	N/A	N/A	DWS Full Width?	N/A
N/A	Landing Curb? (Y/N)	N/A	N/A	DWS Offset (in)	N/A
N/A	Shared Landing?	N/A			
N/A	Gutter Ponding?	N/A	N/A	Gutter Slope (%)	N/A
N/A	Gutter Lip Ht (in)	N/A	N/A	Gutter X Slope (%)	N/A
N/A	Painted X Walk1?	No	N/A	Painted X Walk2?	N/A
	X Walk 1 Direction	To NE		X Walk 2 Direction	N/A
N/A	X Walk 1 Width (in)	N/A	N/A	X Walk 2 Width (in)	N/A
	X Walk 1 Slope (%)	1.4		X Walk 2 Slope (%)	N/A
	X Walk 1 X Slope (%)	3.1		X Walk 2 X Slope (%)	N/A

N/A	Ramp inside XWalk1?	N/A	N/A	Ramp inside XWalk2?	N/A
	Road Slope (%)	N/A	N/A	Clear Space?	N/A
	Road X Slope (%)	N/A	N/A	Clear Space to XWalk (in)	N/A
N/A	Any Obstructions?	N/A	N/A	Storm Grate/Utility Hazard?	N/A
	Obstruction Type			Storm Grate/Utility Type	
		N/A			N/A
			Yes	Surface Condition? (G/P)	Good

Remove & Replace Entire Ramp.
