Access Compliance Report

Public Rights-of-Way

(Curb Ramps)

Intersection ID: 11566	Main Street: GRANDIN_RD	Cross Street: LITAKER_AV	Location: N
ADA ID: F0FA2B90C43A	Ramp Type: Perp	Initial Pass/Fail: Fail	Overall Compliance: No
Severity Score: 12.5			
Codes/Mitigation Info/Possible Solution		Field Measurements/Component Compliance

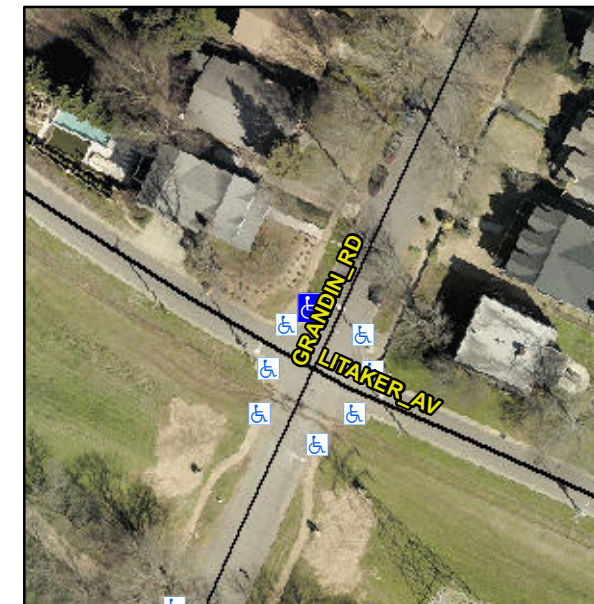
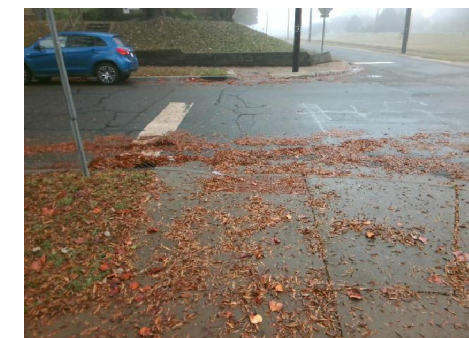
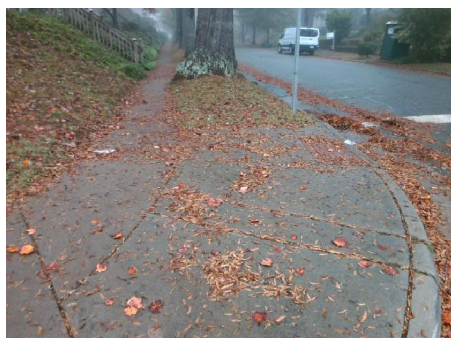
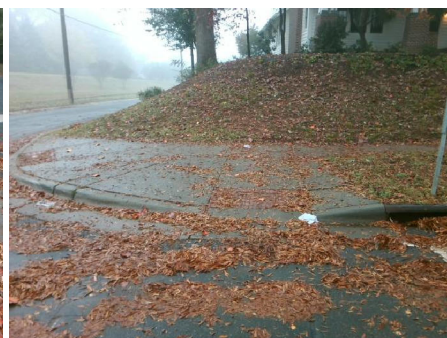
Not Found, R304.2.2

Compliance	Description	Data	Compliance	Description	Data
N/A	Ramp Length (in)	90.0	No	Ramp Slope (%)	10.1
Yes	Ramp Width (in)	48.0	Yes	Ramp XSlope (%)	0.2
N/A	Flare Type LT	N/A	N/A	Flare Type RT	N/A
N/A	Flare Slope LT (%)	N/A	N/A	Flare Slope RT (%)	N/A
N/A	Flare Traversable LT?	N/A	N/A	Flare Traversable RT?	N/A
N/A	Landing Length (in)	N/A	N/A	DWS Provided?	N/A
N/A	Landing Width (in)	N/A	N/A	DWS Contrast?	N/A
N/A	Landing Slope (%)	N/A	N/A	DWS Length (in)	N/A
N/A	Landing X Slope (%)	N/A	N/A	DWS Full Width?	N/A
N/A	Landing Curb? (Y/N)	N/A	N/A	DWS Offset (in)	N/A
N/A	Shared Landing?	N/A			
N/A	Gutter Ponding?	N/A	N/A	Gutter Slope (%)	N/A
N/A	Gutter Lip Ht (in)	N/A	N/A	Gutter X Slope (%)	N/A
N/A	Painted X Walk1?	No	N/A	Painted X Walk2?	N/A
	X Walk 1 Direction	To SE		X Walk 2 Direction	N/A
N/A	X Walk 1 Width (in)	N/A	N/A	X Walk 2 Width (in)	N/A
	X Walk 1 Slope (%)	2.4		X Walk 2 Slope (%)	N/A
	X Walk 1 X Slope (%)	2.3		X Walk 2 X Slope (%)	N/A

N/A	Ramp inside XWalk1?	N/A	N/A	Ramp inside XWalk2?	N/A
	Road Slope (%)	N/A	N/A	Clear Space?	N/A
	Road X Slope (%)	N/A	N/A	Clear Space to XWalk (in)	N/A
N/A	Any Obstructions?	N/A	N/A	Storm Grate/Utility Hazard?	N/A
	Obstruction Type			Storm Grate/Utility Type	
		N/A			N/A
		Yes		Surface Condition? (G/P)	Good

Remove & Replace Entire Ramp.
