Access Compliance Report

Public Rights-of-Way

(Curb Ramps)

Intersection ID: 12504	Main Street: N_BREVARD_ST	Cross Street: E_5TH_ST	Location: N
ADA ID: F0FE7C344A60	Ramp Type: Perp	Initial Pass/Fail: Pass	Overall Compliance: No
Severity Score: 0.25			
Codes/Mitigation Info/Possible Solution		Field Measurements/Component Compliance

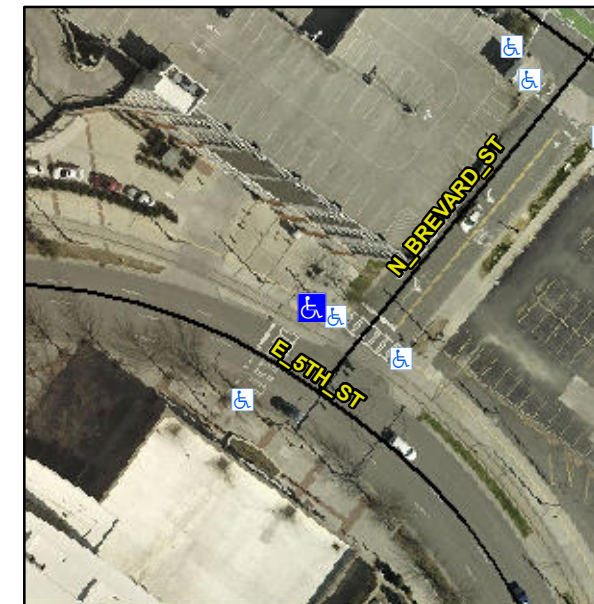
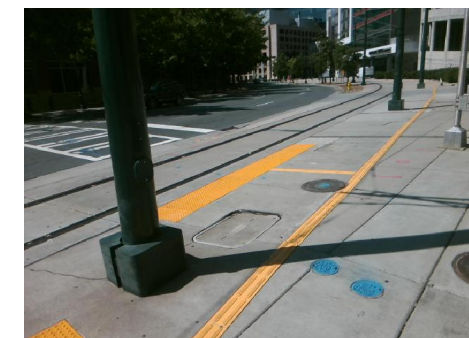
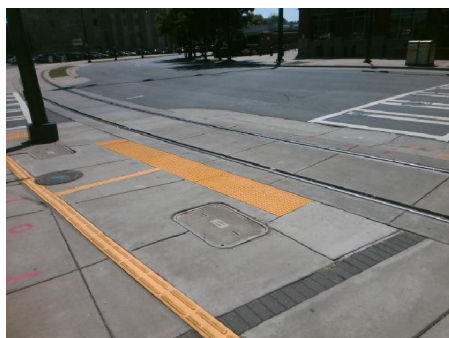
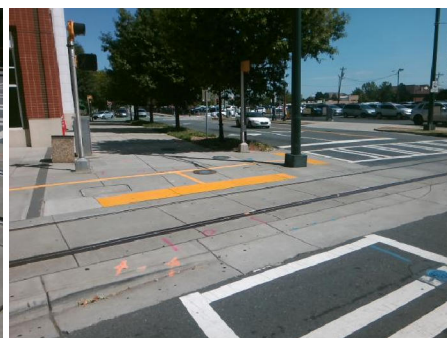
Compliance	Description	Data	Compliance	Description	Data
N/A	Ramp Length (in)	120.0	Yes	Ramp Slope (%)	6.0
Yes	Ramp Width (in)	120.0	No	Ramp XSlope (%)	4.2
N/A	Flare Type LT	Sloped	N/A	Flare Type RT	N/A
N/A	Flare Slope LT (%)	3.8	Yes	Flare Slope RT (%)	0.8
N/A	Flare Traversable LT?	Yes	N/A	Flare Traversable RT?	Yes
Yes	Landing Length (in)	48.0	Yes	DWS Provided?	Yes
Yes	Landing Width (in)	48.0	Yes	DWS Contrast?	Yes
Yes	Landing Slope (%)	0.8	Yes	DWS Length (in)	24.0
No	Landing X Slope (%)	2.6	Yes	DWS Full Width?	Yes
N/A	Landing Curb? (Y/N)	No	Yes	DWS Offset (in)	0.0
N/A	Shared Landing?	No			
Yes	Gutter Ponding?	No	Yes	Gutter Slope (%)	0.8
Yes	Gutter Lip Ht (in)	0.0	Yes	Gutter X Slope (%)	1.6
N/A	Painted X Walk1?	Yes	N/A	Painted X Walk2?	N/A
	X Walk 1 Direction	To SW		X Walk 2 Direction	N/A
N/A	X Walk 1 Width (in)	104.0	N/A	X Walk 2 Width (in)	N/A
	X Walk 1 Slope (%)	2.7		X Walk 2 Slope (%)	N/A
	X Walk 1 X Slope (%)	1.4		X Walk 2 X Slope (%)	N/A

Yes	Ramp inside XWalk1?	Yes	N/A	Ramp inside XWalk2?	N/A
	Road Slope (%)	N/A	N/A	Clear Space?	Yes
	Road X Slope (%)	N/A	N/A	Clear Space to XWalk (in)	N/A
Yes	Any Obstructions?	No	Yes	Storm Grate/Utility Hazard?	No
	Obstruction Type			Storm Grate/Utility Type	
		N/A			N/A
			Yes	Surface Condition? (G/P)	Good

Possible Solutions:

Remove & Replace Entire Ramp.

R304.5.3

\$ 1850.00
