# Access Compliance Report

## Public Rights-of-Way

### (Curb Ramps)

Intersection ID: 43849	Main Street: BRADSTREET COMMONS WY	Cross Street: COZEN WY	Location: NW
ADA ID: F103D622EBD0	Ramp Type: Perp	Initial Pass/Fail: Fail	Overall Compliance: No
Severity Score: 46.25			
Codes/Mitigation Info/Possible Solution		Field Measurements/Component Compliance

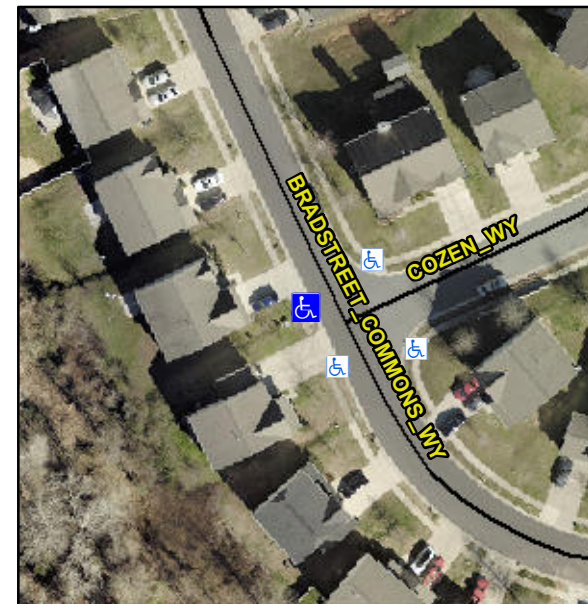
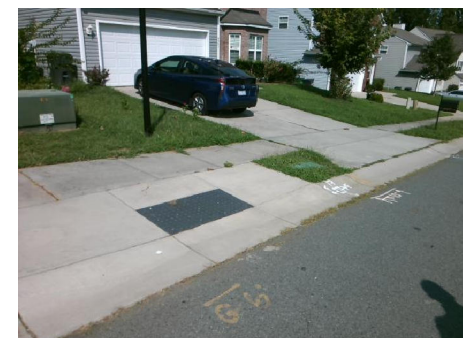
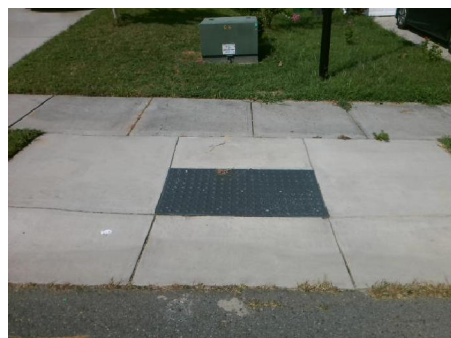
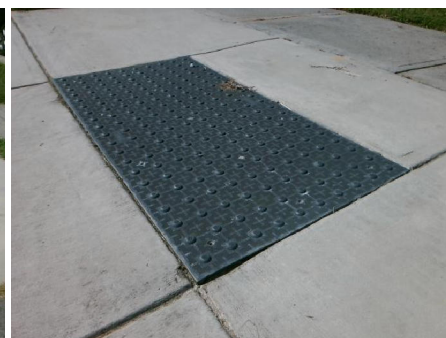
**Not Found, R304.5.1, R304.2.2, R304.5.3**

Compliance	Description	Data	Compliance	Description	Data
N/A	Ramp Length (in)	58.0	No	Ramp Slope (%)	14.6
No	Ramp Width (in)	47.5	No	Ramp XSlope (%)	6.2
N/A	Flare Type LT	N/A	N/A	Flare Type RT	N/A
N/A	Flare Slope LT (%)	N/A	N/A	Flare Slope RT (%)	N/A
N/A	Flare Traversable LT?	N/A	N/A	Flare Traversable RT?	N/A
N/A	Landing Length (in)	N/A	N/A	DWS Provided?	N/A
N/A	Landing Width (in)	N/A	N/A	DWS Contrast?	N/A
N/A	Landing Slope (%)	N/A	N/A	DWS Length (in)	N/A
N/A	Landing X Slope (%)	N/A	N/A	DWS Full Width?	N/A
N/A	Landing Curb? (Y/N)	N/A	N/A	DWS Offset (in)	N/A
N/A	Shared Landing?	N/A			
N/A	Gutter Ponding?	N/A	N/A	Gutter Slope (%)	N/A
N/A	Gutter Lip Ht (in)	N/A	N/A	Gutter X Slope (%)	N/A
N/A	Painted X Walk1?	No	N/A	Painted X Walk2?	N/A
	X Walk 1 Direction	To NE		X Walk 2 Direction	N/A
N/A	X Walk 1 Width (in)	N/A	N/A	X Walk 2 Width (in)	N/A
	X Walk 1 Slope (%)	3.8		X Walk 2 Slope (%)	N/A
	X Walk 1 X Slope (%)	8.6		X Walk 2 X Slope (%)	N/A

N/A	Ramp inside XWalk1?	N/A	N/A	Ramp inside XWalk2?	N/A
	Road Slope (%)	N/A	N/A	Clear Space?	N/A
	Road X Slope (%)	N/A	N/A	Clear Space to XWalk (in)	N/A
N/A	Any Obstructions?	N/A	N/A	Storm Grate/Utility Hazard?	N/A
	Obstruction Type			Storm Grate/Utility Type	
		N/A			N/A
			Yes	Surface Condition? (G/P)	Good

**Remove & Replace Entire Ramp.**

Total Cost: \$ **1850.00**
