# Access Compliance Report

## Public Rights-of-Way

### (Curb Ramps)

Intersection ID: 10018518	Main Street: DUMONT_LN	Cross Street: N/A	Location: S
ADA ID: F108924EEE06	Ramp Type: Perp	Initial Pass/Fail: Fail	Overall Compliance: No
Severity Score: 26.25			
Codes/Mitigation Info/Possible Solution		Field Measurements/Component Compliance

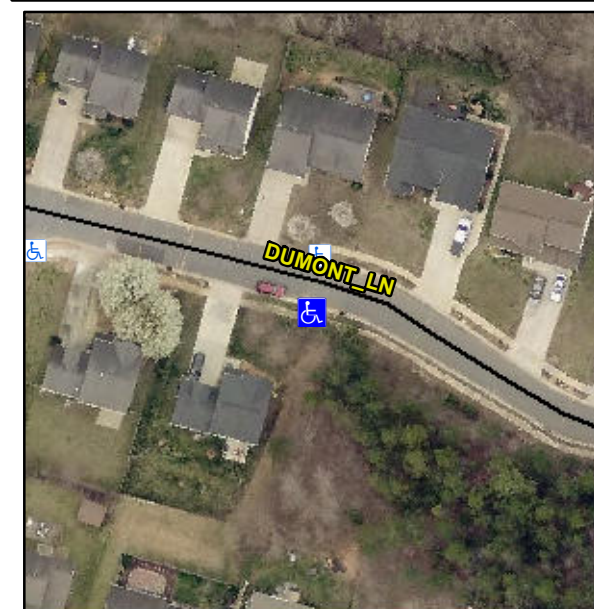
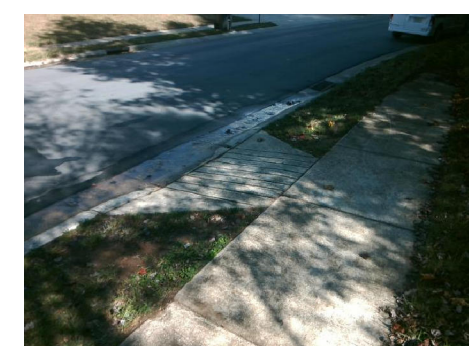
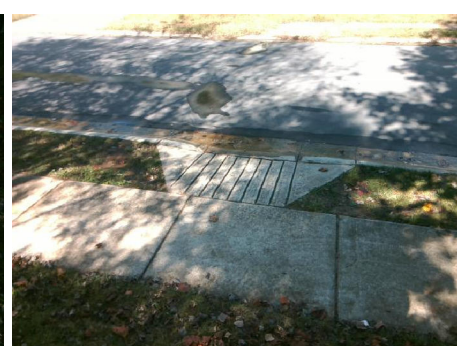
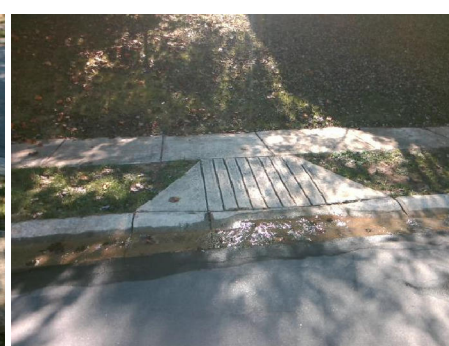
Compliance	Description	Data	Compliance	Description	Data
N/A	Ramp Length (in)	48.0	No	Ramp Slope (%)	14.8
Yes	Ramp Width (in)	49.0	No	Ramp XSlope (%)	3.8
N/A	Flare Type LT	N/A	N/A	Flare Type RT	N/A
N/A	Flare Slope LT (%)	N/A	N/A	Flare Slope RT (%)	N/A
N/A	Flare Traversable LT?	N/A	N/A	Flare Traversable RT?	N/A
N/A	Landing Length (in)	N/A	N/A	DWS Provided?	N/A
N/A	Landing Width (in)	N/A	N/A	DWS Contrast?	N/A
N/A	Landing Slope (%)	N/A	N/A	DWS Length (in)	N/A
N/A	Landing X Slope (%)	N/A	N/A	DWS Full Width?	N/A
N/A	Landing Curb? (Y/N)	N/A	N/A	DWS Offset (in)	N/A
N/A	Shared Landing?	N/A			
N/A	Gutter Ponding?	N/A	N/A	Gutter Slope (%)	N/A
N/A	Gutter Lip Ht (in)	N/A	N/A	Gutter X Slope (%)	N/A
N/A	Painted X Walk1?	No	N/A	Painted X Walk2?	N/A
	X Walk 1 Direction	To N		X Walk 2 Direction	N/A
N/A	X Walk 1 Width (in)	N/A	N/A	X Walk 2 Width (in)	N/A
	X Walk 1 Slope (%)	1.4		X Walk 2 Slope (%)	N/A
	X Walk 1 X Slope (%)	2.7		X Walk 2 X Slope (%)	N/A

N/A	Ramp inside XWalk1?	N/A	N/A	Ramp inside XWalk2?	N/A
	Road Slope (%)	N/A	N/A	Clear Space?	N/A
	Road X Slope (%)	N/A	N/A	Clear Space to XWalk (in)	N/A
N/A	Any Obstructions?	N/A	N/A	Storm Grate/Utility Hazard?	N/A
	Obstruction Type			Storm Grate/Utility Type	
		N/A			N/A
			Yes	Surface Condition? (G/P)	Good

**Remove & Replace Entire Ramp.**

**R304.2.2, R304.5.3**

**\$ 1850.00**
