Access Compliance Report

Public Rights-of-Way

(Curb Ramps)

Intersection ID: 31506	Main Street: CHARIDGE_LN	Cross Street: STONEY_CREEK_LN	Location: SE
ADA ID: F10CD07E1EB4	Ramp Type: PerpDiag	Initial Pass/Fail: Fail	Overall Compliance: No
		Severity Score: 30

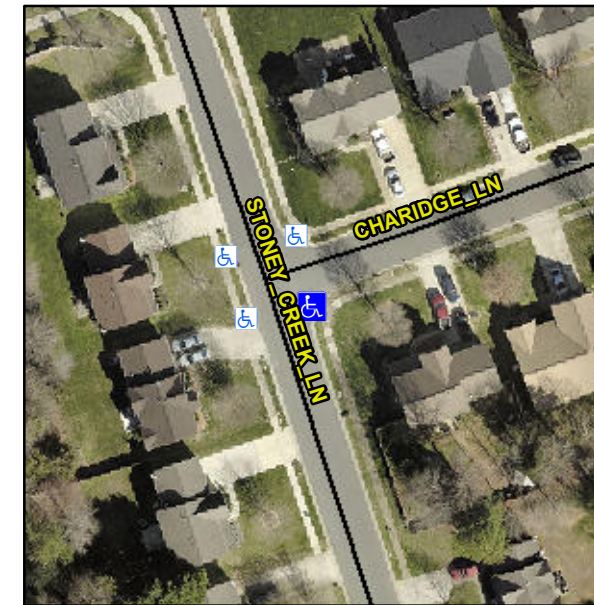
Not Found, R304.5.1, R304.2.2

Compliance	Description	Data	Compliance	Description	Data
N/A	Ramp Length (in)	47.0	No	Ramp Slope (%)	10.5
No	Ramp Width (in)	35.0	Yes	Ramp XSlope (%)	1.3
N/A	Flare Type LT	N/A	N/A	Flare Type RT	N/A
N/A	Flare Slope LT (%)	N/A	N/A	Flare Slope RT (%)	N/A
N/A	Flare Traversable LT?	N/A	N/A	Flare Traversable RT?	N/A
N/A	Landing Length (in)	N/A	N/A	DWS Provided?	N/A
N/A	Landing Width (in)	N/A	N/A	DWS Contrast?	N/A
N/A	Landing Slope (%)	N/A	N/A	DWS Length (in)	N/A
N/A	Landing X Slope (%)	N/A	N/A	DWS Full Width?	N/A
N/A	Landing Curb? (Y/N)	N/A	N/A	DWS Offset (in)	N/A
N/A	Shared Landing?	N/A			
N/A	Gutter Ponding?	N/A	N/A	Gutter Slope (%)	N/A
N/A	Gutter Lip Ht (in)	0.5	N/A	Gutter X Slope (%)	N/A
N/A	Painted X Walk1?	No	N/A	Painted X Walk2?	No
	X Walk 1 Direction	To N		X Walk 2 Direction	To W
N/A	X Walk 1 Width (in)	N/A	N/A	X Walk 2 Width (in)	N/A
	X Walk 1 Slope (%)	3.6		X Walk 2 Slope (%)	3.5
	X Walk 1 X Slope (%)	3.0		X Walk 2 X Slope (%)	2.3

N/A	Ramp inside XWalk1?	N/A	N/A	Ramp inside XWalk2?	N/A
	Road Slope (%)	0.8	N/A	Clear Space?	N/A
	Road X Slope (%)	5.2	N/A	Clear Space to XWalk (in)	N/A
N/A	Any Obstructions?	N/A	N/A	Storm Grate/Utility Hazard?	N/A
	Obstruction Type			Storm Grate/Utility Type	
		N/A			N/A
			Yes	Surface Condition? (G/P)	Good

Remove & Replace Curb Ramp With Two New Directional Ramps or Equivalent.
