## Access Compliance Report Public Rights-of-Way (Curb Ramps)

Intersection ID: 47573 Main Street: SEDGEBURN\_DR Cross Street: GAILES\_DR Location: SW

ADA ID: F124538B205A Ramp Type: PerpDiag Initial Pass/Fail: Fail Overall Compliance: No Severity Score: 13.75

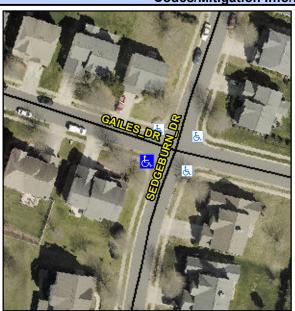
Comp	liance Description	Data	Comp	liance Description	Data
N/A	Ramp Length (in)	47.0	No	Ramp Slope (%)	10.1
Yes	Ramp Width (in)	48.0	No	Ramp XSlope (%)	3.6
N/A	Flare Type LT	N/A	N/A	Flare Type RT	N/A
N/A	Flare Slope LT (%)	N/A	N/A	Flare Slope RT (%)	N/A
N/A	Flare Traversable LT?	N/A	N/A	Flare Traversable RT?	N/A
N/A	Landing Length (in)	N/A	N/A	DWS Provided?	N/A
N/A	Landing Width (in)	N/A	N/A	DWS Contrast?	N/A
N/A	Landing Slope (%)	N/A	N/A	DWS Length (in)	N/A
N/A	Landing X Slope (%)	N/A	N/A	DWS Full Width?	N/A
N/A	Landing Curb? (Y/N)	N/A	N/A	DWS Offset (in)	N/A
N/A	Shared Landing?	N/A			
N/A	Gutter Ponding?	N/A	N/A	Gutter Slope (%)	N/A
N/A	Gutter Lip Ht (in)	N/A	N/A	Gutter X Slope (%)	N/A
N/A	Painted X Walk1?	No	N/A	Painted X Walk2?	No
	X Walk 1 Direction	To SE		X Walk 2 Direction	To NE
N/A	X Walk 1 Width (in)	N/A	N/A	X Walk 2 Width (in)	N/A
	X Walk 1 Slope (%)	5.4		X Walk 2 Slope (%)	3.2
	X Walk 1 X Slope (%)	0.4		X Walk 2 X Slope (%)	3.5

N/A	Ramp inside XWalk1?	N/A	N/A	Ramp inside XWalk2?	N/A
	Road Slope (%)	2.8	N/A	Clear Space?	N/A
	Road X Slope (%)	1.9	N/A	Clear Space to XWalk (in)	N/A
N/A	Any Obstructions?	N/A	N/A	Storm Grate/Utility Hazard?	N/A
	Obstruction Type		l	Storm Grate/Utility Type	
		N/A			N/A

Remove & Replace Curb Ramp With
Two New Directional Ramps or
Equivalent.

PROW/ADA: **R304.2.2**, **R304.5.3**
