Access Compliance Report

Public Rights-of-Way

(Curb Ramps)

Intersection ID: 3647	Main Street: TIFTON GRASS LN	Cross Street: TRADITION VIEW DR	Location: SE
ADA ID: F12B4B51FB14	Ramp Type: Perp	Initial Pass/Fail: Fail	Overall Compliance: No
Severity Score: 33.75			
Codes/Mitigation Info/Possible Solution		Field Measurements/Component Compliance

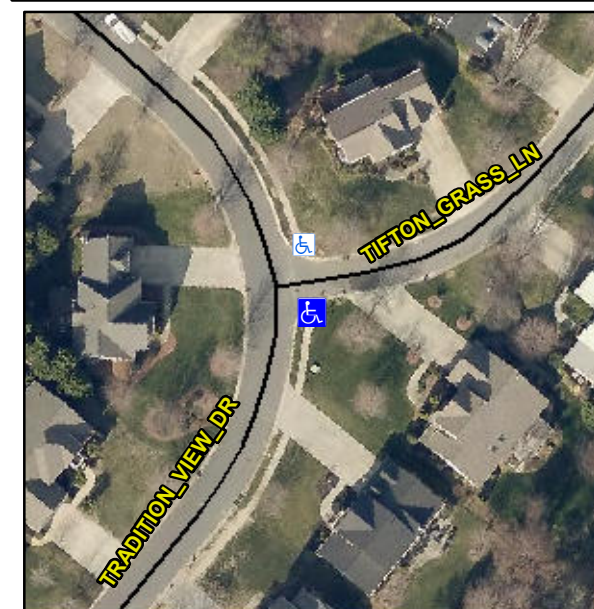
Not Found, R304.5.1, R304.5.3

Compliance	Description	Data	Compliance	Description	Data
N/A	Ramp Length (in)	98.5	Yes	Ramp Slope (%)	6.3
No	Ramp Width (in)	47.0	No	Ramp XSlope (%)	8.1
N/A	Flare Type LT	N/A	N/A	Flare Type RT	N/A
N/A	Flare Slope LT (%)	N/A	N/A	Flare Slope RT (%)	N/A
N/A	Flare Traversable LT?	N/A	N/A	Flare Traversable RT?	N/A
N/A	Landing Length (in)	N/A	N/A	DWS Provided?	N/A
N/A	Landing Width (in)	N/A	N/A	DWS Contrast?	N/A
N/A	Landing Slope (%)	N/A	N/A	DWS Length (in)	N/A
N/A	Landing X Slope (%)	N/A	N/A	DWS Full Width?	N/A
N/A	Landing Curb? (Y/N)	N/A	N/A	DWS Offset (in)	N/A
N/A	Shared Landing?	N/A			
N/A	Gutter Ponding?	N/A	N/A	Gutter Slope (%)	N/A
N/A	Gutter Lip Ht (in)	N/A	N/A	Gutter X Slope (%)	N/A
N/A	Painted X Walk1?	No	N/A	Painted X Walk2?	N/A
	X Walk 1 Direction	To N		X Walk 2 Direction	N/A
N/A	X Walk 1 Width (in)	N/A	N/A	X Walk 2 Width (in)	N/A
	X Walk 1 Slope (%)	1.2		X Walk 2 Slope (%)	N/A
	X Walk 1 X Slope (%)	3.6		X Walk 2 X Slope (%)	N/A

Remove & Replace Entire Ramp.
