# Access Compliance Report

## Public Rights-of-Way

| Intersection ID: 2733 | Main Street: CARDINAL_POINT_RD | Cross Street: SWEETFIELD_DR | Location: W |
| ADA ID: F13069E0BE1A | Ramp Type: Perp | Initial Pass/Fail: Fail | Overall Compliance: No |

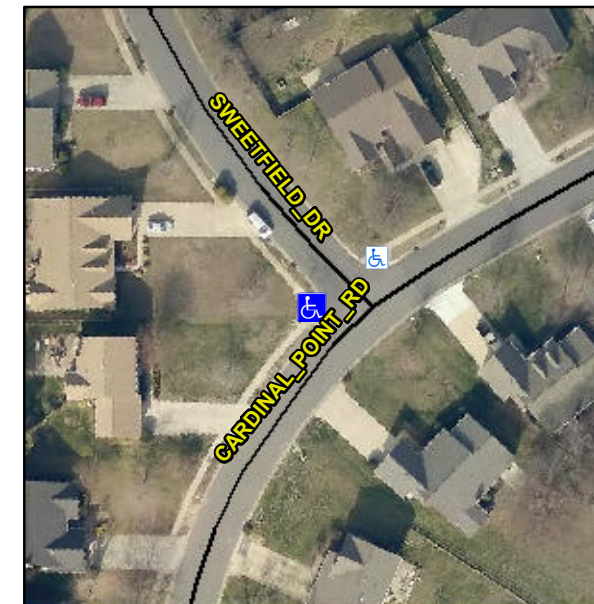
| Severity Score: 13.75 | | | |

**R304.2.2, R304.5.3**

| Compliance | Description | Data | Compliance | Description | Data |
|---|---|---|---|---|---|
| N/A | Ramp Length (in) | 54.5 | No | Ramp Slope (%) | 10.3 |
| Yes | Ramp Width (in) | 53.0 | No | Ramp XSlope (%) | 4.5 |

**Remove & Replace Entire Ramp.**

Total Cost: \$ 1850.00
