Access Compliance Report

Public Rights-of-Way

(Curb Ramps)

Intersection ID: 11140	Main Street: N_SYCAMORE_ST	Cross Street: W_5TH_ST	Location: S
ADA ID: F13BD85735E9	Ramp Type: Directional1	Initial Pass/Fail: Pass	Overall Compliance: No
		Severity Score: 0

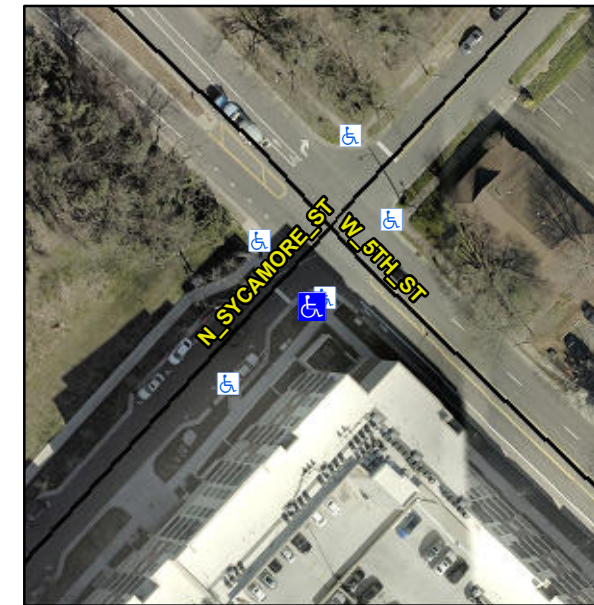
Compliance	Description	Data	Compliance	Description	Data
N/A	Ramp Length (in)	102.0	Yes	Grade Break?	Yes
Yes	Ramp Width (in)	70.5	No	Grade Break Slope (%)	6.7
Yes	Ramp Slope (%)	6.8	No	Grade Break XSlope (%)	3.8
Yes	Ramp XSlope (%)	1.5			
Yes	Flare Type LT	N/A	Yes	Flare Type RT	N/A
N/A	Flare Slope LT (%)	N/A	N/A	Flare Slope RT (%)	N/A
N/A	Flare Traversable LT?	No	N/A	Flare Traversable RT?	No
Yes	Landing Length (in)	71.0	Yes	DWS Provided?	Yes
Yes	Landing Width (in)	70.5	Yes	DWS Contrast?	Yes
No	Landing Slope (%)	2.7	Yes	DWS Length (in)	24.0
Yes	Landing X Slope (%)	1.4	Yes	DWS Full Width?	Yes
N/A	Landing Curb? (Y/N)	N/A	Yes	DWS Offset LT (in)	1.0
N/A	Shared Landing?	Yes	Yes	DWS Offset RT (in)	30.0
Yes	Gutter Ponding?	No	Yes	Gutter Slope (%)	0.8
Yes	Gutter Lip Ht (in)	0.0	No	Gutter X Slope (%)	6.6
N/A	Painted X Walk1?	No		Road Slope (%)	2.8
	X Walk 1 Direction	To NW		Road X Slope (%)	4.7
	X Walk 1 Width (in)	N/A		Clear Space?	Yes

X Walk 1 Slope (%)	2.8	N/A	Clear Space to XWalk (in)	N/A
	X Walk 1 X Slope (%)	4.7	Yes	Storm Grate/Utility Hazard?	No
N/A	Ramp inside XWalk1?	N/A		Storm Grate/Utility Type	
Yes	Any Obstructions?	No			N/A
	Obstruction Type		Yes	Surface Condition? (G/P)	Good
			N/A	Curb Slope (%)	3.4

**Remove & Replace Entire Ramp.
Remove & Replace Gutter.**

**R304.2.2-Perp, R304.3.2-Para,
R304.5.3**
