# Access Compliance Report

## Public Rights-of-Way

### (Curb Ramps)

| Intersection ID: 29226 | Main Street: KORNIV_DR | Cross Street: ROZUMNY_DR | Location: SW |

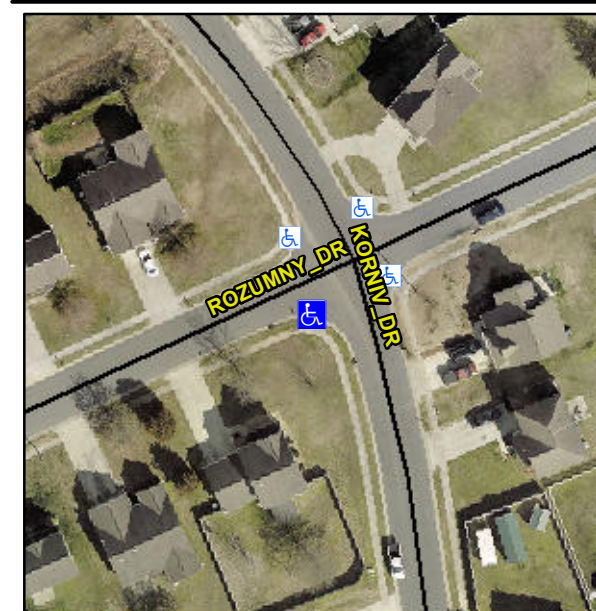
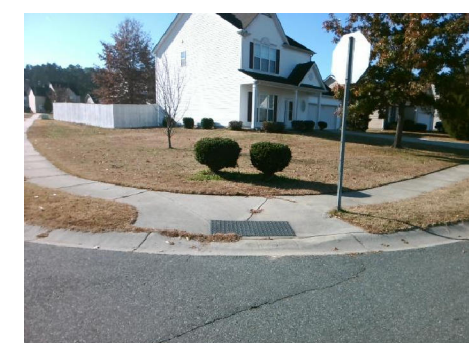
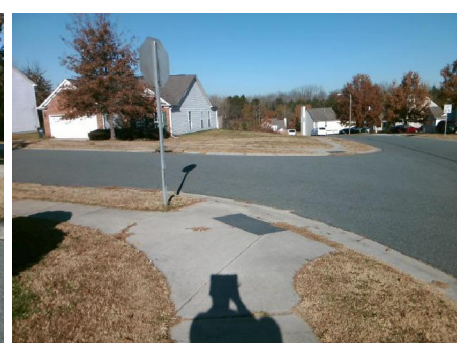
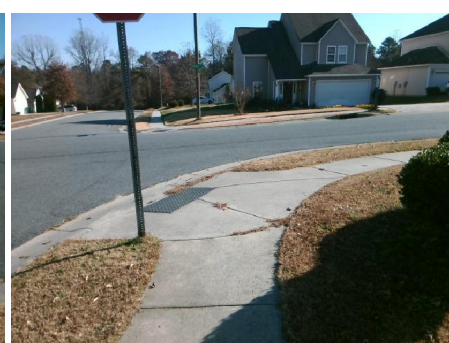
**Not Found, R304.5.3, R304.2.1, R304.2.2-Perp, R304.3.2-Para, R305.1.4, R305.2, R304.5.4**

| Compliance | Description | Data | Compliance | Description | Data |
|---|---|---|---|---|---|
| Yes | Ramp Width (in) | 63.0 | No | Ramp XSlope (%) | 3.6 |
| No | Landing Length (in) | 42.0 | Yes | DWS Provided? | Yes |
| No | Landing Slope (%) | 3.6 | Yes | DWS Length (in) | 24.5 |
| No | Landing X Slope (%) | 3.0 | No | DWS Full Width? | No |
| N/A | Landing Curb? (Y/N) | No | No | DWS Offset (in) | 3.0 |
| Yes | Gutter Ponding? | No | No | Gutter Slope (%) | 6.1 |

**Remove & Replace Curb Ramp With Two New Directional Ramps or Equivalent. Remove & Replace Gutter.**
