Access Compliance Report

Public Rights-of-Way

(Curb Ramps)

Intersection ID: 13010	Main Street: HICKORY GROVE RD	Cross Street: DOGWOOD PL	Location: NW
ADA ID: F15847D87B10	Ramp Type: PerpDiag	Initial Pass/Fail: Fail	Overall Compliance: No
Codes/Mitigation Info/Possible Solution		Field Measurements/Component Compliance

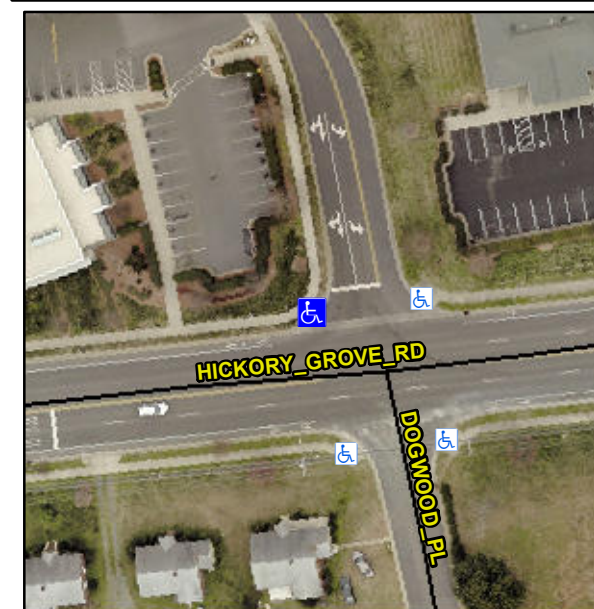
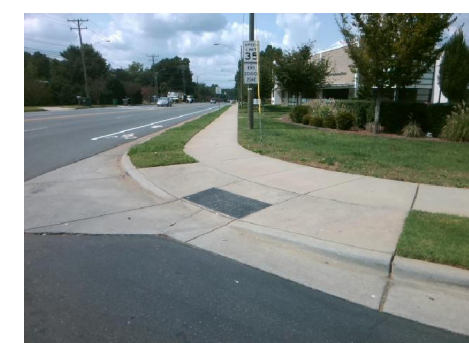
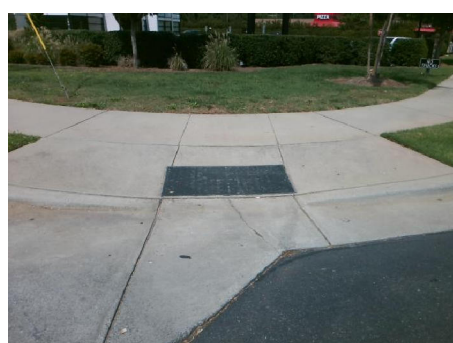
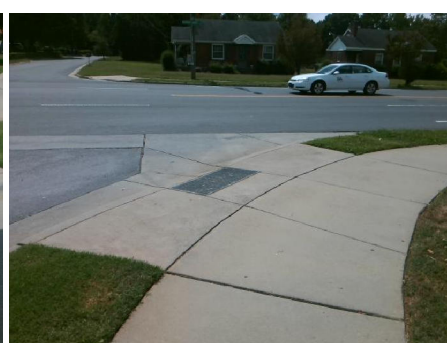
Not Found, R304.5.1, R304.2.2

Compliance	Description	Data	Compliance	Description	Data
N/A	Ramp Length (in)	47.0	No	Ramp Slope (%)	8.4
No	Ramp Width (in)	46.0	Yes	Ramp XSlope (%)	0.4
N/A	Flare Type LT	N/A	N/A	Flare Type RT	N/A
N/A	Flare Slope LT (%)	N/A	N/A	Flare Slope RT (%)	N/A
N/A	Flare Traversable LT?	N/A	N/A	Flare Traversable RT?	N/A
N/A	Landing Length (in)	N/A	N/A	DWS Provided?	N/A
N/A	Landing Width (in)	N/A	N/A	DWS Contrast?	N/A
N/A	Landing Slope (%)	N/A	N/A	DWS Length (in)	N/A
N/A	Landing X Slope (%)	N/A	N/A	DWS Full Width?	N/A
N/A	Landing Curb? (Y/N)	N/A	N/A	DWS Offset (in)	N/A
N/A	Shared Landing?	N/A			
N/A	Gutter Ponding?	N/A	N/A	Gutter Slope (%)	N/A
N/A	Gutter Lip Ht (in)	0.5	N/A	Gutter X Slope (%)	N/A
N/A	Painted X Walk1?	No	N/A	Painted X Walk2?	No
	X Walk 1 Direction	To S		X Walk 2 Direction	To E
N/A	X Walk 1 Width (in)	N/A	N/A	X Walk 2 Width (in)	N/A
	X Walk 1 Slope (%)	0.8		X Walk 2 Slope (%)	1.8
	X Walk 1 X Slope (%)	0.2		X Walk 2 X Slope (%)	2.3

N/A	Ramp inside XWalk1?	N/A	N/A	Ramp inside XWalk2?	N/A
	Road Slope (%)	0.2	N/A	Clear Space?	N/A
	Road X Slope (%)	3.2	N/A	Clear Space to XWalk (in)	N/A
N/A	Any Obstructions?	N/A	N/A	Storm Grate/Utility Hazard?	N/A
	Obstruction Type			Storm Grate/Utility Type	
		N/A			N/A
			Yes	Surface Condition? (G/P)	Good

Remove & Replace Curb Ramp With Two New Directional Ramps or Equivalent.
