Access Compliance Report

Public Rights-of-Way

(Curb Ramps)

Intersection ID: 6766	Main Street: INDIAN RIDGE LN	Cross Street: WINDING CANYON DR	Location: E
ADA ID: F17A564DF828	Ramp Type: Perp	Initial Pass/Fail: Fail	Overall Compliance: No
		Severity Score: 12.5

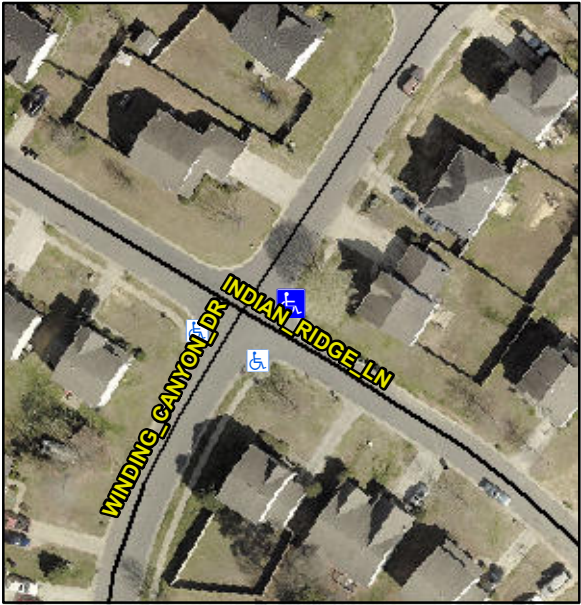
Possible Solutions:		Compliance	Description	Data
	Remove & Replace Entire Ramp.		N/A	Ramp Length (in)	48.0
			Yes	Ramp Width (in)	48.0
			N/A	Flare Type LT	N/A
			N/A	Flare Slope LT (%)	N/A
			N/A	Flare Traversable LT?	N/A
			N/A	Landing Length (in)	N/A
			N/A	Landing Width (in)	N/A
			N/A	Landing Slope (%)	N/A
			N/A	Landing X Slope (%)	N/A
<p>Surveyor Notes:</p> <p>N/A</p> <p>PROW/ADA:</p> <p>Not Found, R304.2.2</p>			N/A	Flare Type RT	N/A
			N/A	Flare Slope RT (%)	N/A
			N/A	Flare Traversable RT?	N/A
			N/A	DWS Provided?	N/A
			N/A	DWS Contrast?	N/A
			N/A	DWS Length (in)	N/A
			N/A	DWS Full Width?	N/A
			N/A	DWS Offset (in)	N/A
			N/A	Shared Landing?	N/A
			N/A	Gutter Ponding?	N/A
			N/A	Gutter Lip Ht (in)	N/A
			N/A	Painted X Walk1?	No
				X Walk 1 Direction	To SW
			N/A	X Walk 1 Width (in)	N/A
				X Walk 1 Slope (%)	4.0
				X Walk 1 X Slope (%)	0.5

N/A	Ramp inside XWalk1?	N/A
				Road Slope (%)	N/A
				Road X Slope (%)	N/A
			N/A	Any Obstructions?	N/A
				Obstruction Type	
Total Cost:		\$ 1850.00			
			N/A		N/A
			Yes	Surface Condition? (G/P)	Good
