# Access Compliance Report

## Public Rights-of-Way

### (Curb Ramps)

| Intersection ID: 32179 | Main Street: AMONTILLADO_DR | Cross Street: MARIE_ROGET_WY | Location: S |

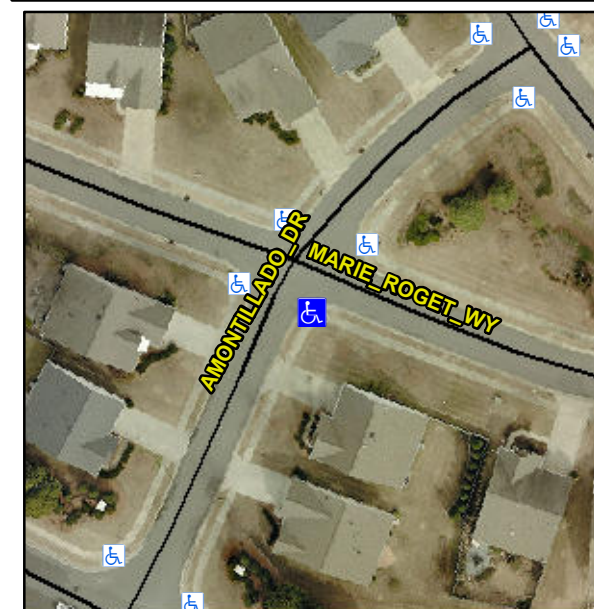
| ADA ID: F17B2B4D661B | Ramp Type: PerpDiag | Initial Pass/Fail: Fail | Overall Compliance: No |

**Not Found, R304.5.1, R304.5.3**

| Compliance | Description | Data | Compliance | Description | Data |
|---|---|---|---|---|---|
| N/A | Ramp Length (in) | 96.0 | Yes | Ramp Slope (%) | 5.0 |
| No | Ramp Width (in) | 44.0 | No | Ramp XSlope (%) | 6.4 |

**Remove & Replace Curb Ramp With Two New Directional Ramps or Equivalent.**
