Access Compliance Report

Public Rights-of-Way

(Curb Ramps)

Intersection ID: 8713	Main Street: BRADFORD_DR	Cross Street: RELIANCE_ST	Location: SE
ADA ID: F17BB590B9DA	Ramp Type: Directional	Initial Pass/Fail: Fail	Overall Compliance: No
Severity Score: 12.5			
Codes/Mitigation Info/Possible Solution		Field Measurements/Component Compliance

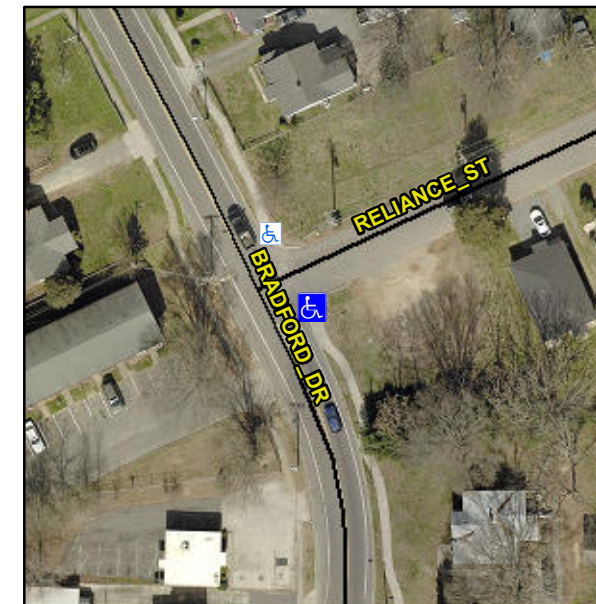
Compliance	Description	Data	Compliance	Description	Data
N/A	Ramp Length (in)	73.0	N/A	Grade Break?	N/A
Yes	Ramp Width (in)	48.0	N/A	Grade Break Slope (%)	0.0
No	Ramp Slope (%)	8.8	N/A	Grade Break XSlope (%)	0.0
Yes	Ramp XSlope (%)	0.2			
N/A	Flare Type LT	N/A	N/A	Flare Type RT	N/A
N/A	Flare Slope LT (%)	N/A	N/A	Flare Slope RT (%)	0.0
N/A	Flare Traversable LT?	N/A	N/A	Flare Traversable RT?	N/A
N/A	Landing Length (in)	0.0	N/A	DWS Provided?	N/A
N/A	Landing Width (in)	0.0	N/A	DWS Contrast?	N/A
N/A	Landing Slope (%)	0.0	N/A	DWS Length (in)	N/A
N/A	Landing X Slope (%)	0.0	N/A	DWS Full Width?	N/A
N/A	Landing Curb? (Y/N)	N/A	N/A	DWS Offset LT (in)	N/A
N/A	Shared Landing?	N/A	N/A	DWS Offset RT (in)	N/A
N/A	Gutter Ponding?	0.0	N/A	Gutter Slope (%)	N/A
N/A	Gutter Lip Ht (in)	0.0	N/A	Gutter X Slope (%)	N/A
N/A	Painted X Walk1?	No		Road Slope (%)	3.6
	X Walk 1 Direction	To NW		Road X Slope (%)	3.8
	X Walk 1 Width (in)	N/A		Clear Space?	N/A

X Walk 1 Slope (%)	3.6	N/A	Clear Space to XWalk (in)	N/A
	X Walk 1 X Slope (%)	3.8	N/A	Storm Grate/Utility Hazard?	N/A
N/A	Ramp inside XWalk1?	N/A		Storm Grate/Utility Type	
N/A	Any Obstructions?	N/A			N/A
	Obstruction Type		Yes	Surface Condition? (G/P)	Good
			N/A	Curb Slope (%)	15.0

Possible Solutions:

Remove & Replace Entire Ramp.
