Access Compliance Report

Public Rights-of-Way

(Curb Ramps)

Intersection ID: 45544	Main Street: HARRIER_RD	Cross Street: CORNIELLE_LN	Location: NE
ADA ID: F1810794007A	Ramp Type: PerpDiag	Initial Pass/Fail: Fail	Overall Compliance: No
Codes/Mitigation Info/Possible Solution		Field Measurements/Component Compliance	
Severity Score: 8.75

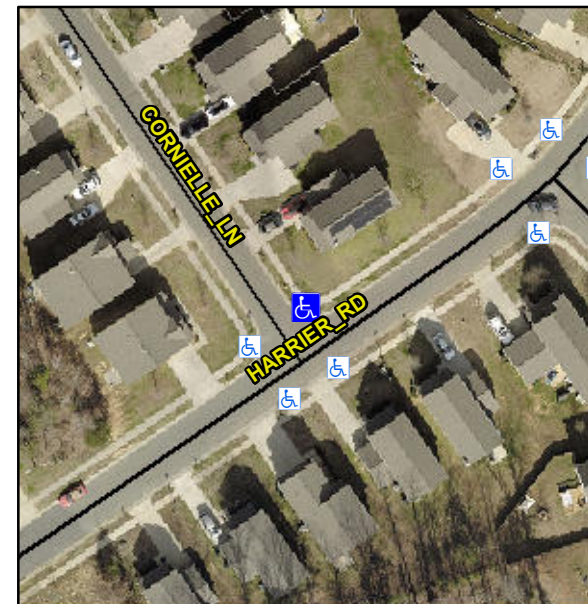
Not Found, R304.5.1

Compliance	Description	Data	Compliance	Description	Data
N/A	Ramp Length (in)	45.0	Yes	Ramp Slope (%)	5.3
No	Ramp Width (in)	45.5	Yes	Ramp XSlope (%)	0.9
N/A	Flare Type LT	N/A	N/A	Flare Type RT	N/A
N/A	Flare Slope LT (%)	N/A	N/A	Flare Slope RT (%)	N/A
N/A	Flare Traversable LT?	N/A	N/A	Flare Traversable RT?	N/A
N/A	Landing Length (in)	N/A	N/A	DWS Provided?	N/A
N/A	Landing Width (in)	N/A	N/A	DWS Contrast?	N/A
N/A	Landing Slope (%)	N/A	N/A	DWS Length (in)	N/A
N/A	Landing X Slope (%)	N/A	N/A	DWS Full Width?	N/A
N/A	Landing Curb? (Y/N)	N/A	N/A	DWS Offset (in)	N/A
N/A	Shared Landing?	N/A			
N/A	Gutter Ponding?	N/A	N/A	Gutter Slope (%)	N/A
N/A	Gutter Lip Ht (in)	1.0	N/A	Gutter X Slope (%)	N/A
N/A	Painted X Walk1?	No	N/A	Painted X Walk2?	No
	X Walk 1 Direction	To W		X Walk 2 Direction	To S
N/A	X Walk 1 Width (in)	N/A	N/A	X Walk 2 Width (in)	N/A
	X Walk 1 Slope (%)	4.3		X Walk 2 Slope (%)	3.5
	X Walk 1 X Slope (%)	3.8		X Walk 2 X Slope (%)	3.9

N/A	Ramp inside XWalk1?	N/A	N/A	Ramp inside XWalk2?	N/A
	Road Slope (%)	0.8	N/A	Clear Space?	N/A
	Road X Slope (%)	5.7	N/A	Clear Space to XWalk (in)	N/A
N/A	Any Obstructions?	N/A	N/A	Storm Grate/Utility Hazard?	N/A
	Obstruction Type			Storm Grate/Utility Type	
		N/A			N/A
			Yes	Surface Condition? (G/P)	Good

Possible Solutions:

Remove & Replace Curb Ramp With Two New Directional Ramps or Equivalent.
